Dredging a Wet Detention Basin

Tim Lynch, PE
RSV Engineering

Leif Hauge, PE, P. Hydrologist
Land Resources Division
Waukesha County Dept. of Parks and
Land Use

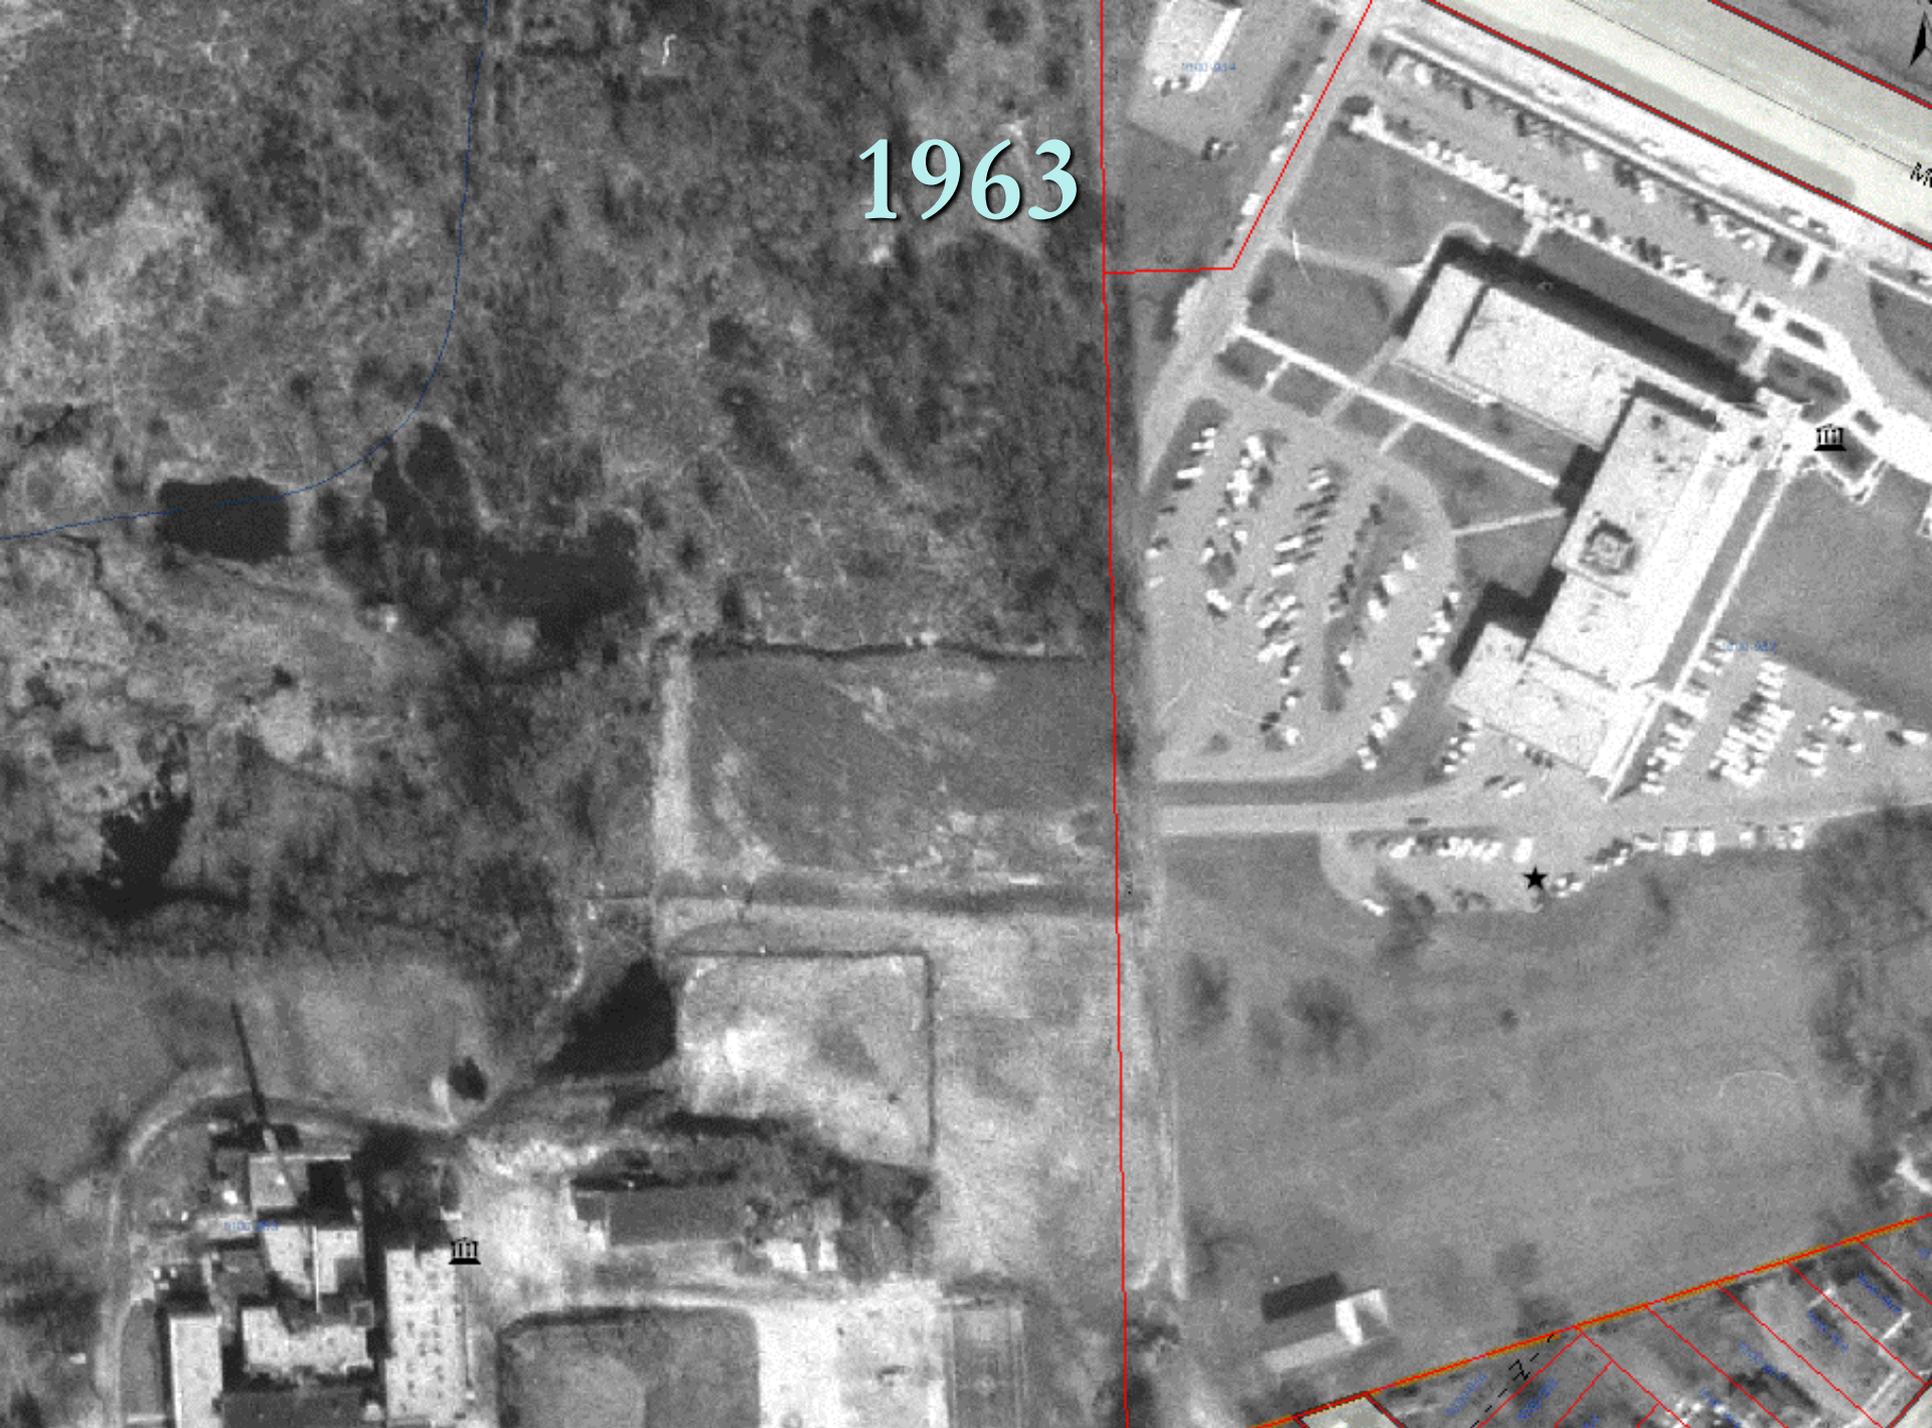
1963

- Pond originally constructed in 1960s as irrigation pond for golf course.
- Re-shaped in 1974 to current extent. Probably lined.
- Soils mapped as Houghton Muck. Actually Pella?
- No soil borings.
- Water table elevation was unknown: 5 feet bls?
- Pond receives runoff from ~ 34 acres, mostly County office campus. Serves as wet detention basin, with four infalls. Current surface area 1.2 acres.
- Discharge to unnamed tributary of Fox R., via City

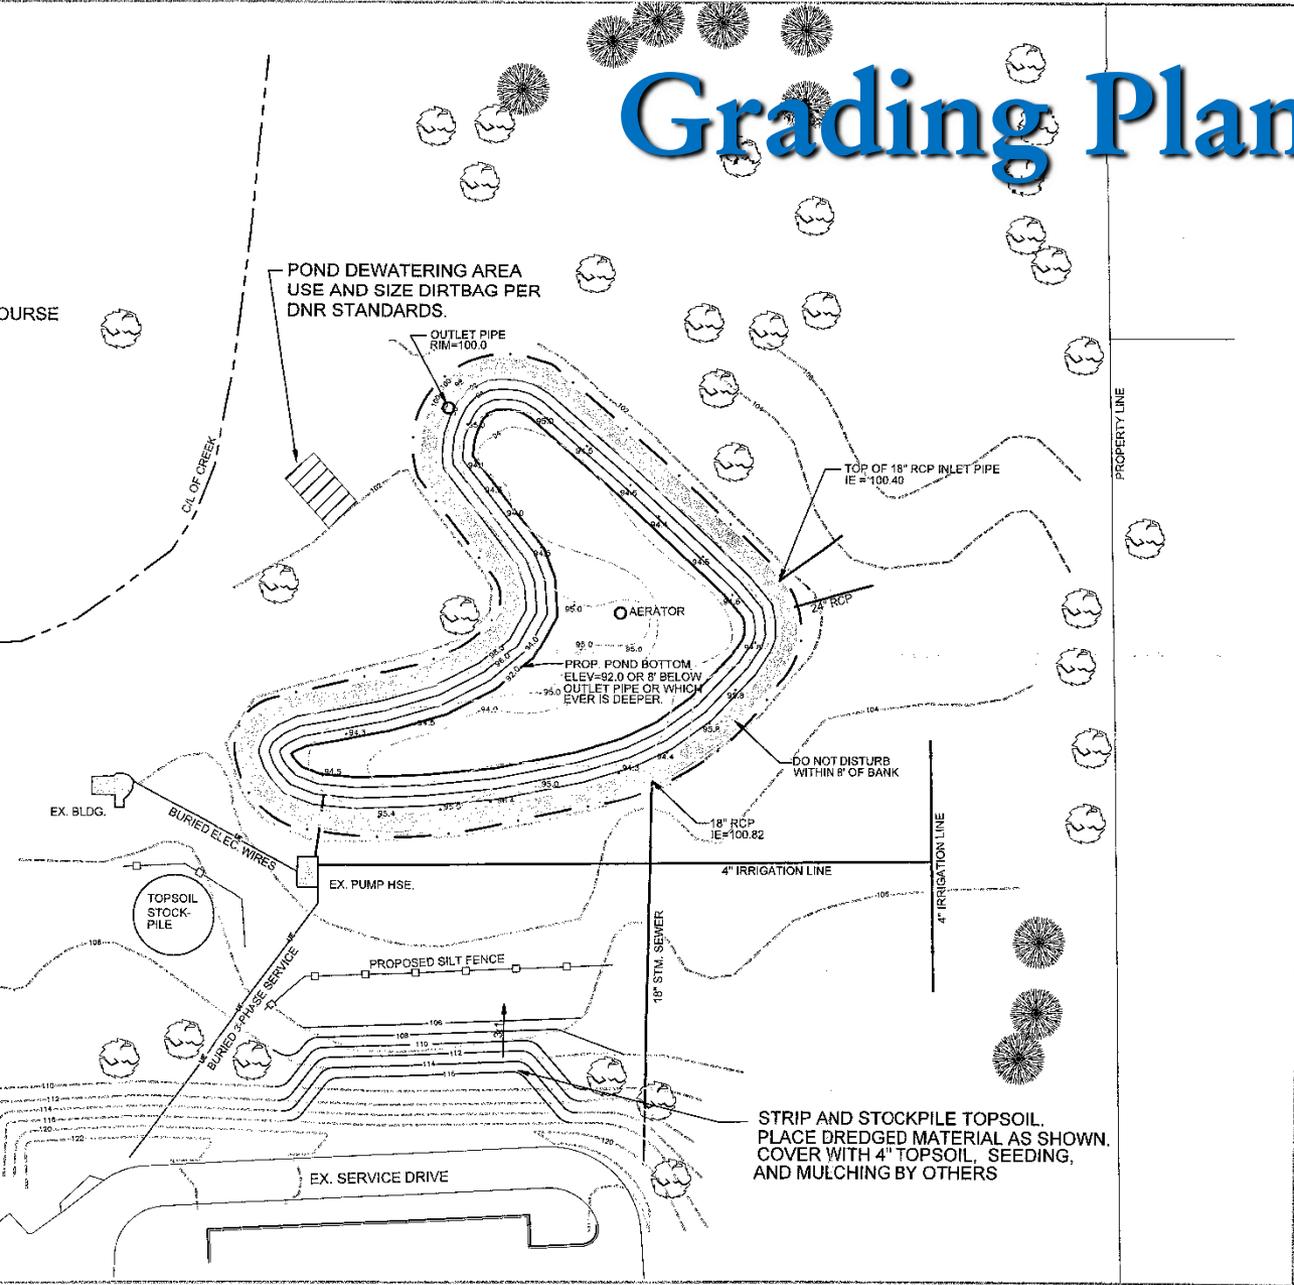
Grading Plan

POND BOTTOM DETAIL

- DO NOT DISTURB POND BOTTOM WITHIN 8 FEET OF POND SHORE.
- PLACE DREDGED SOILS ON SLOPE AS SHOWN.

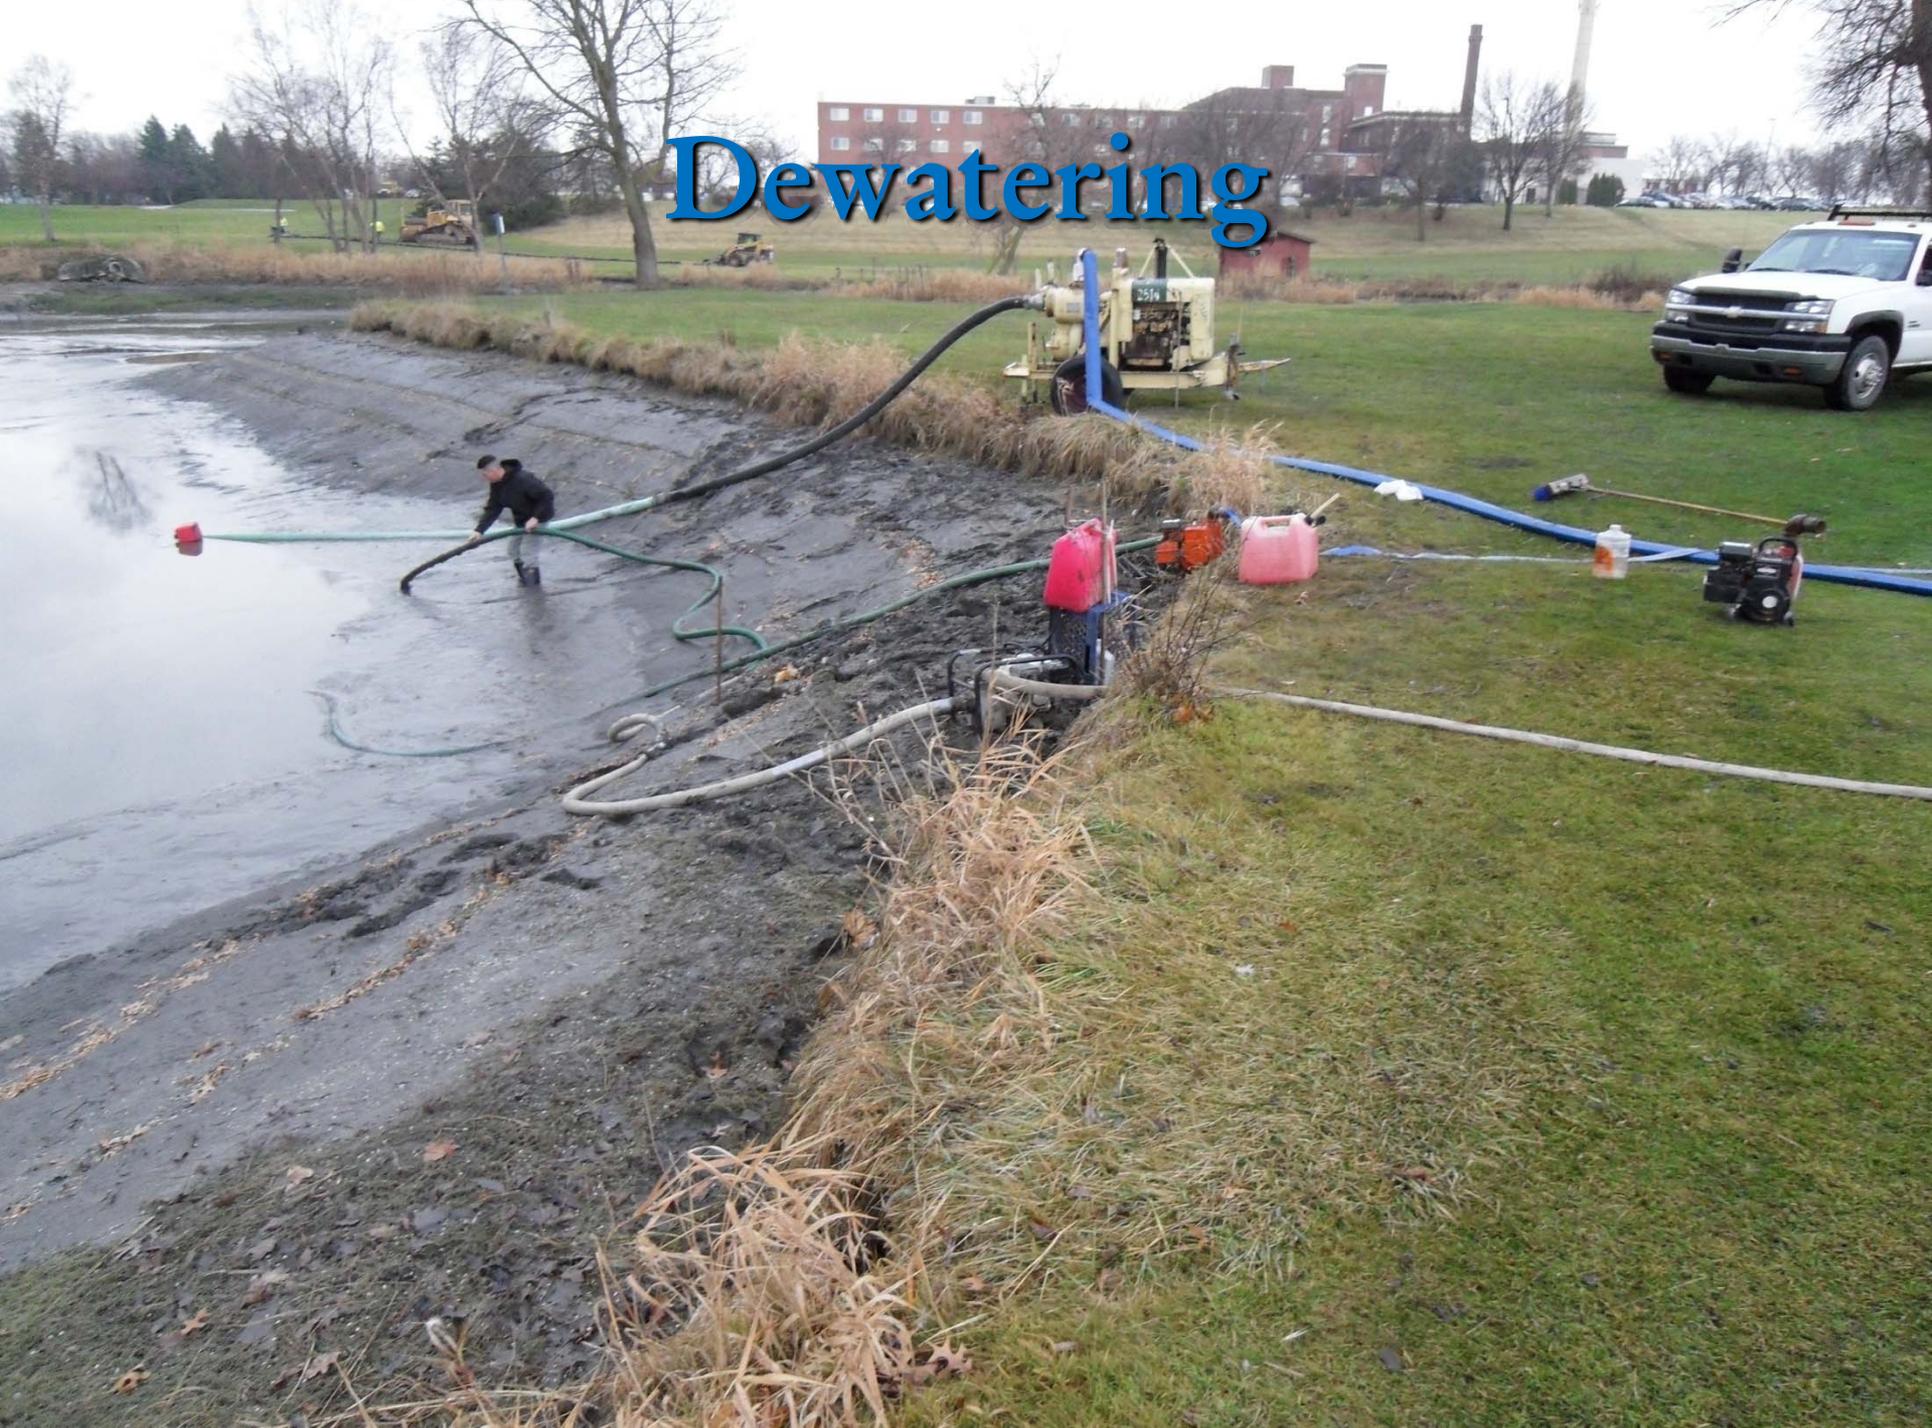
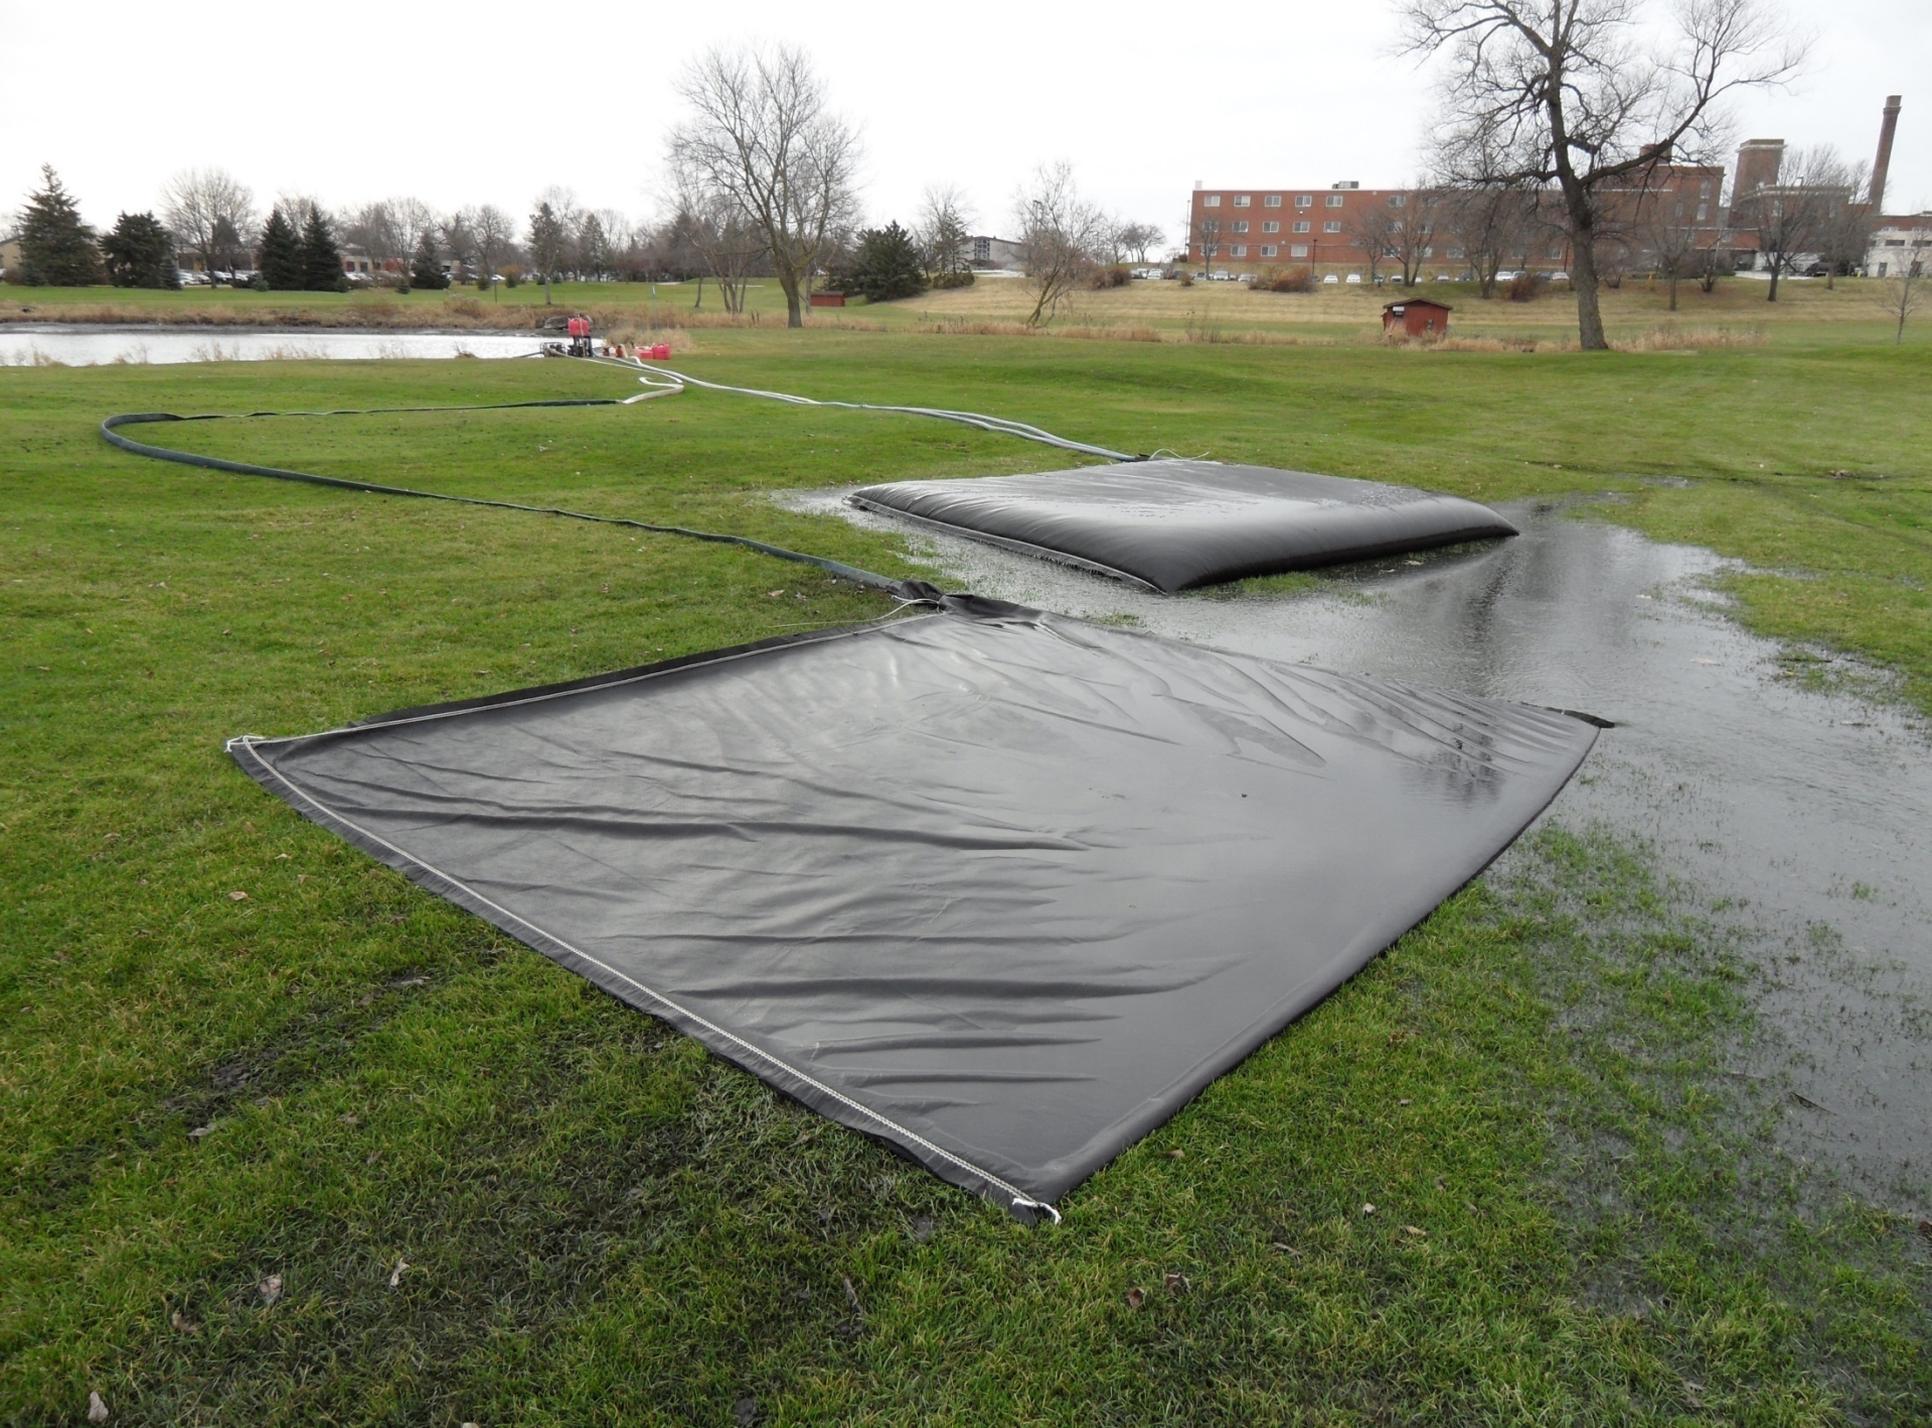
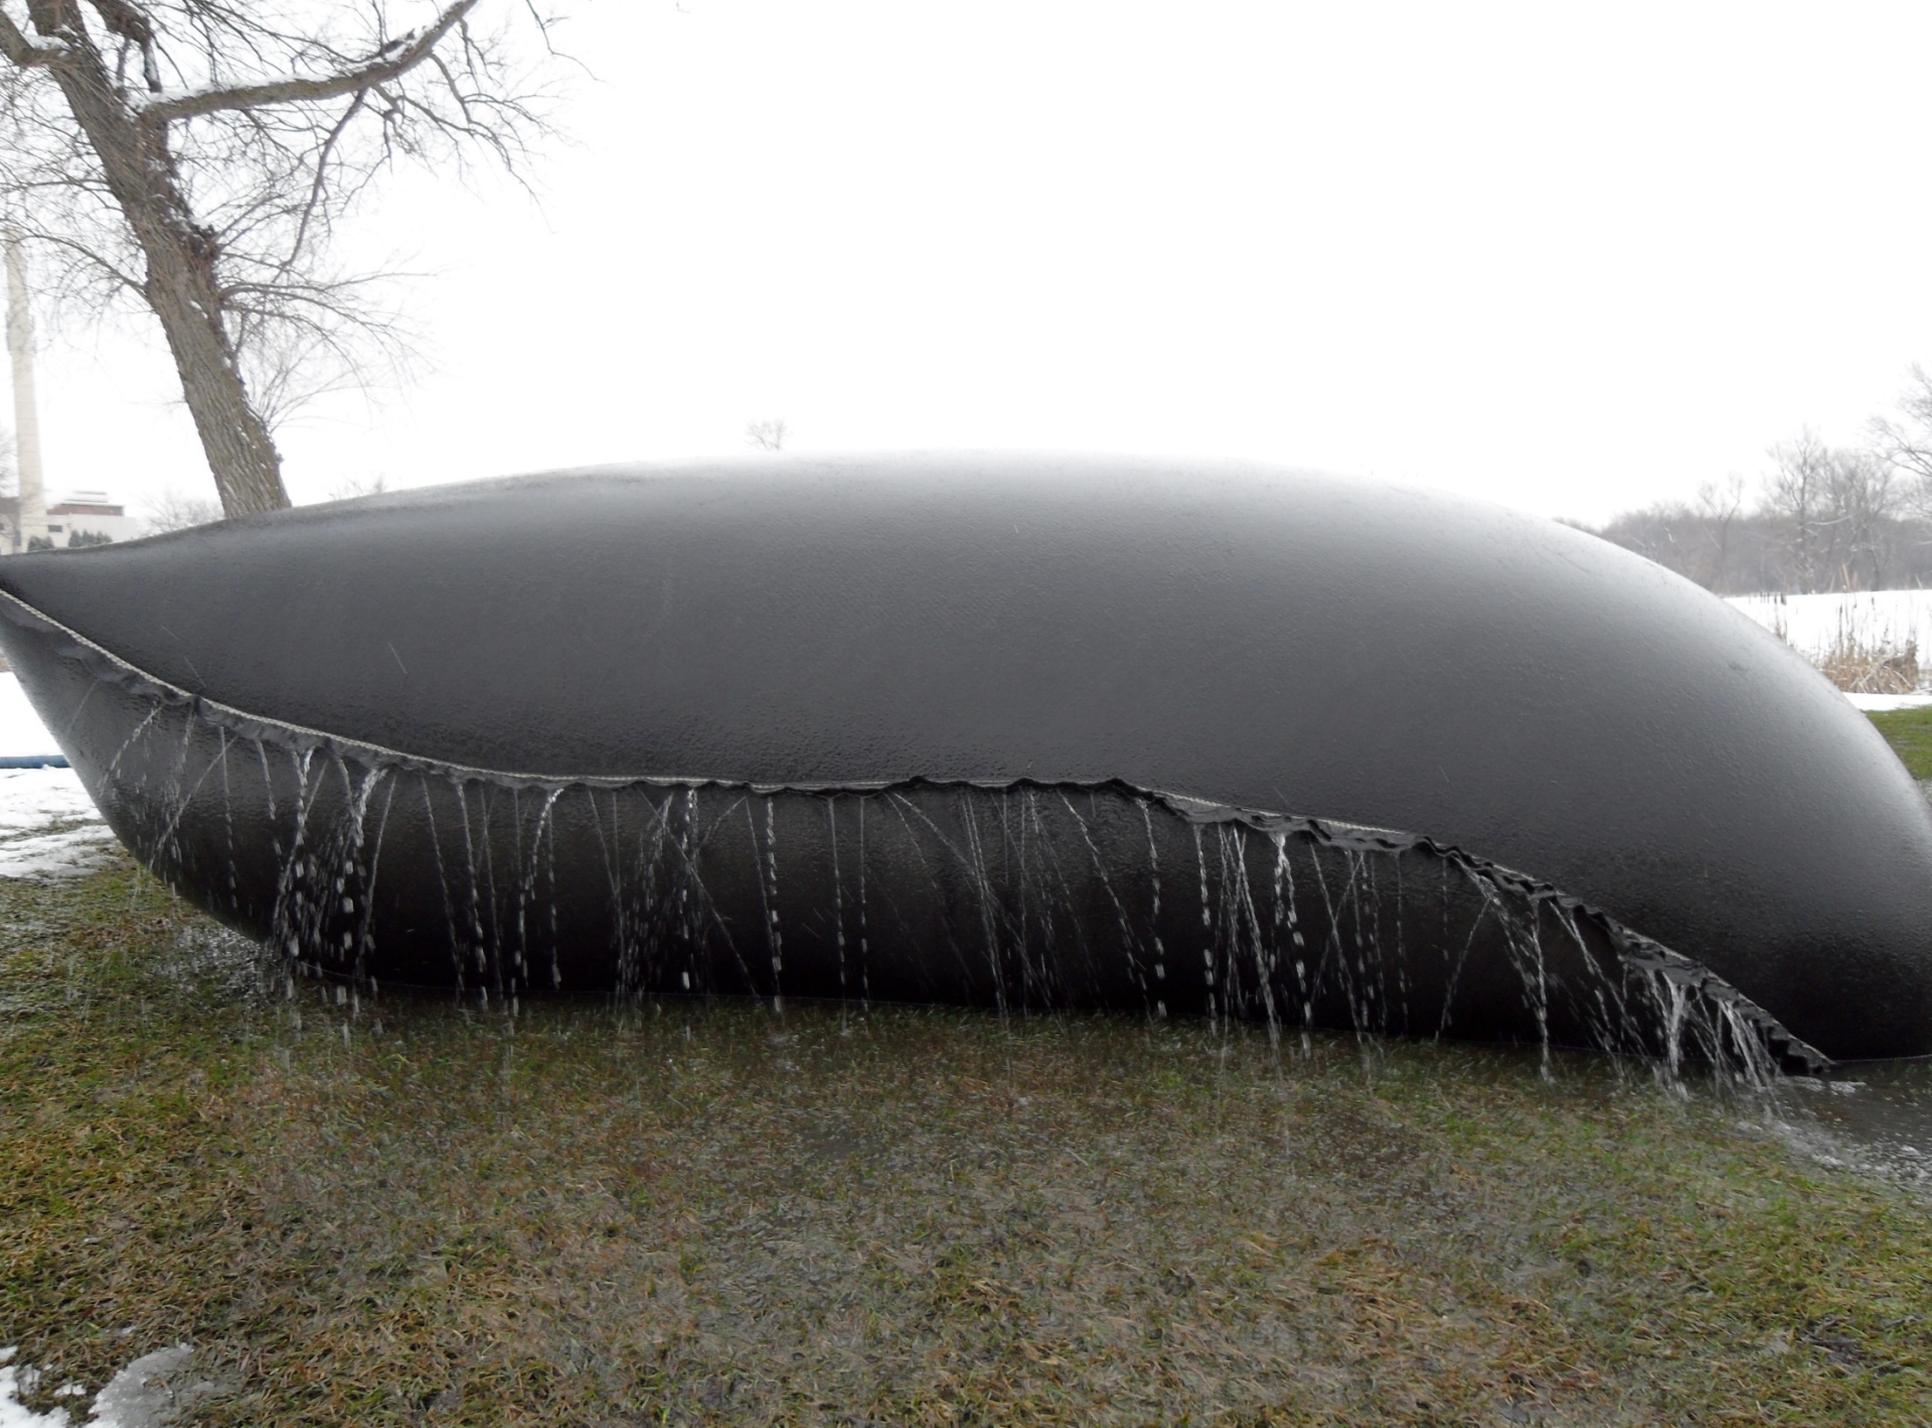
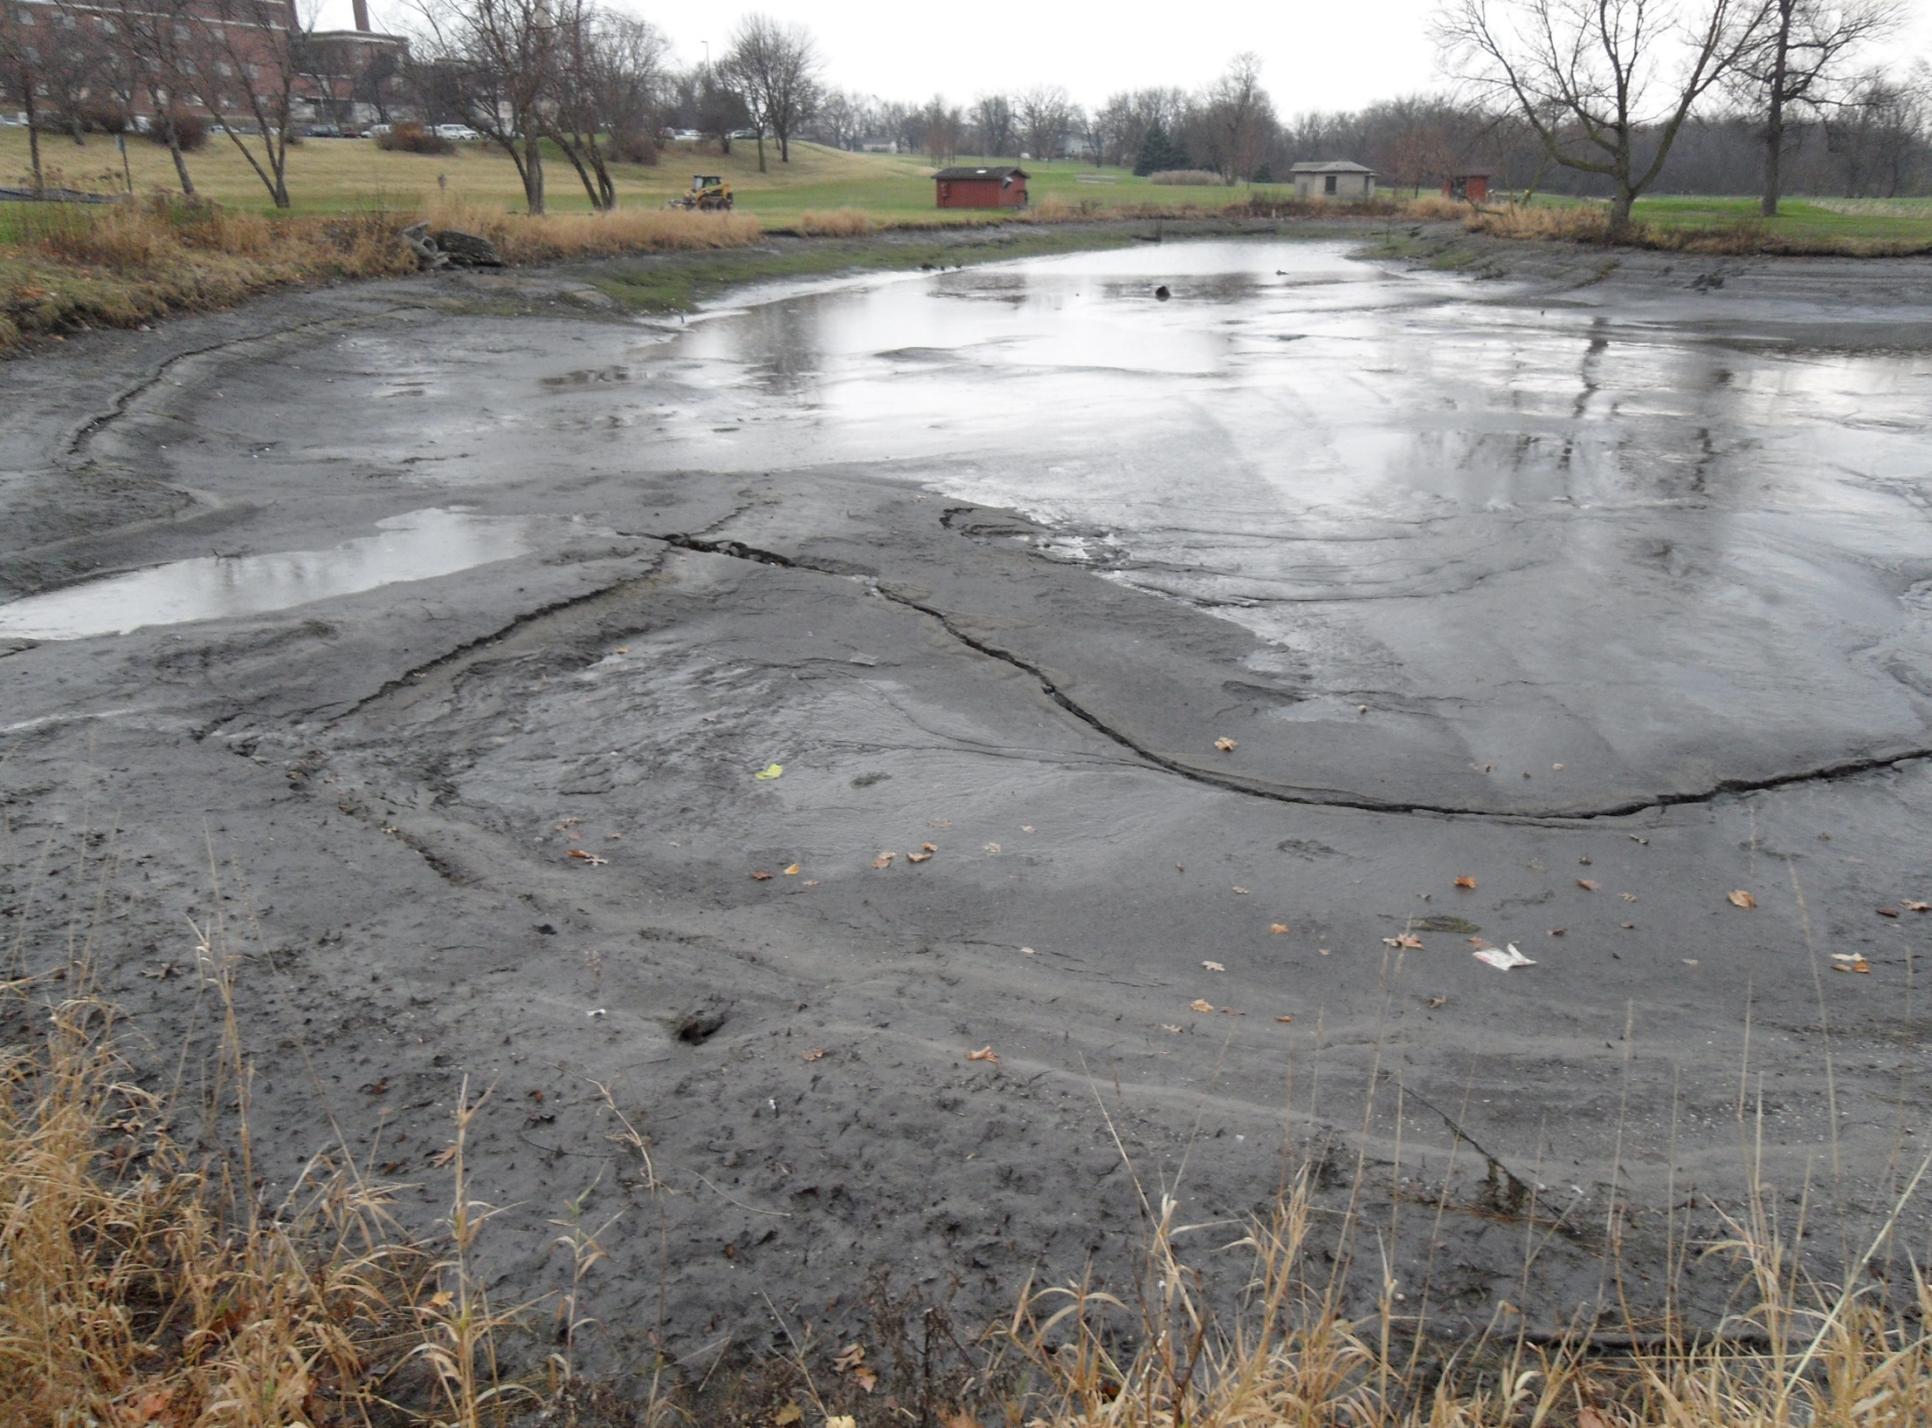
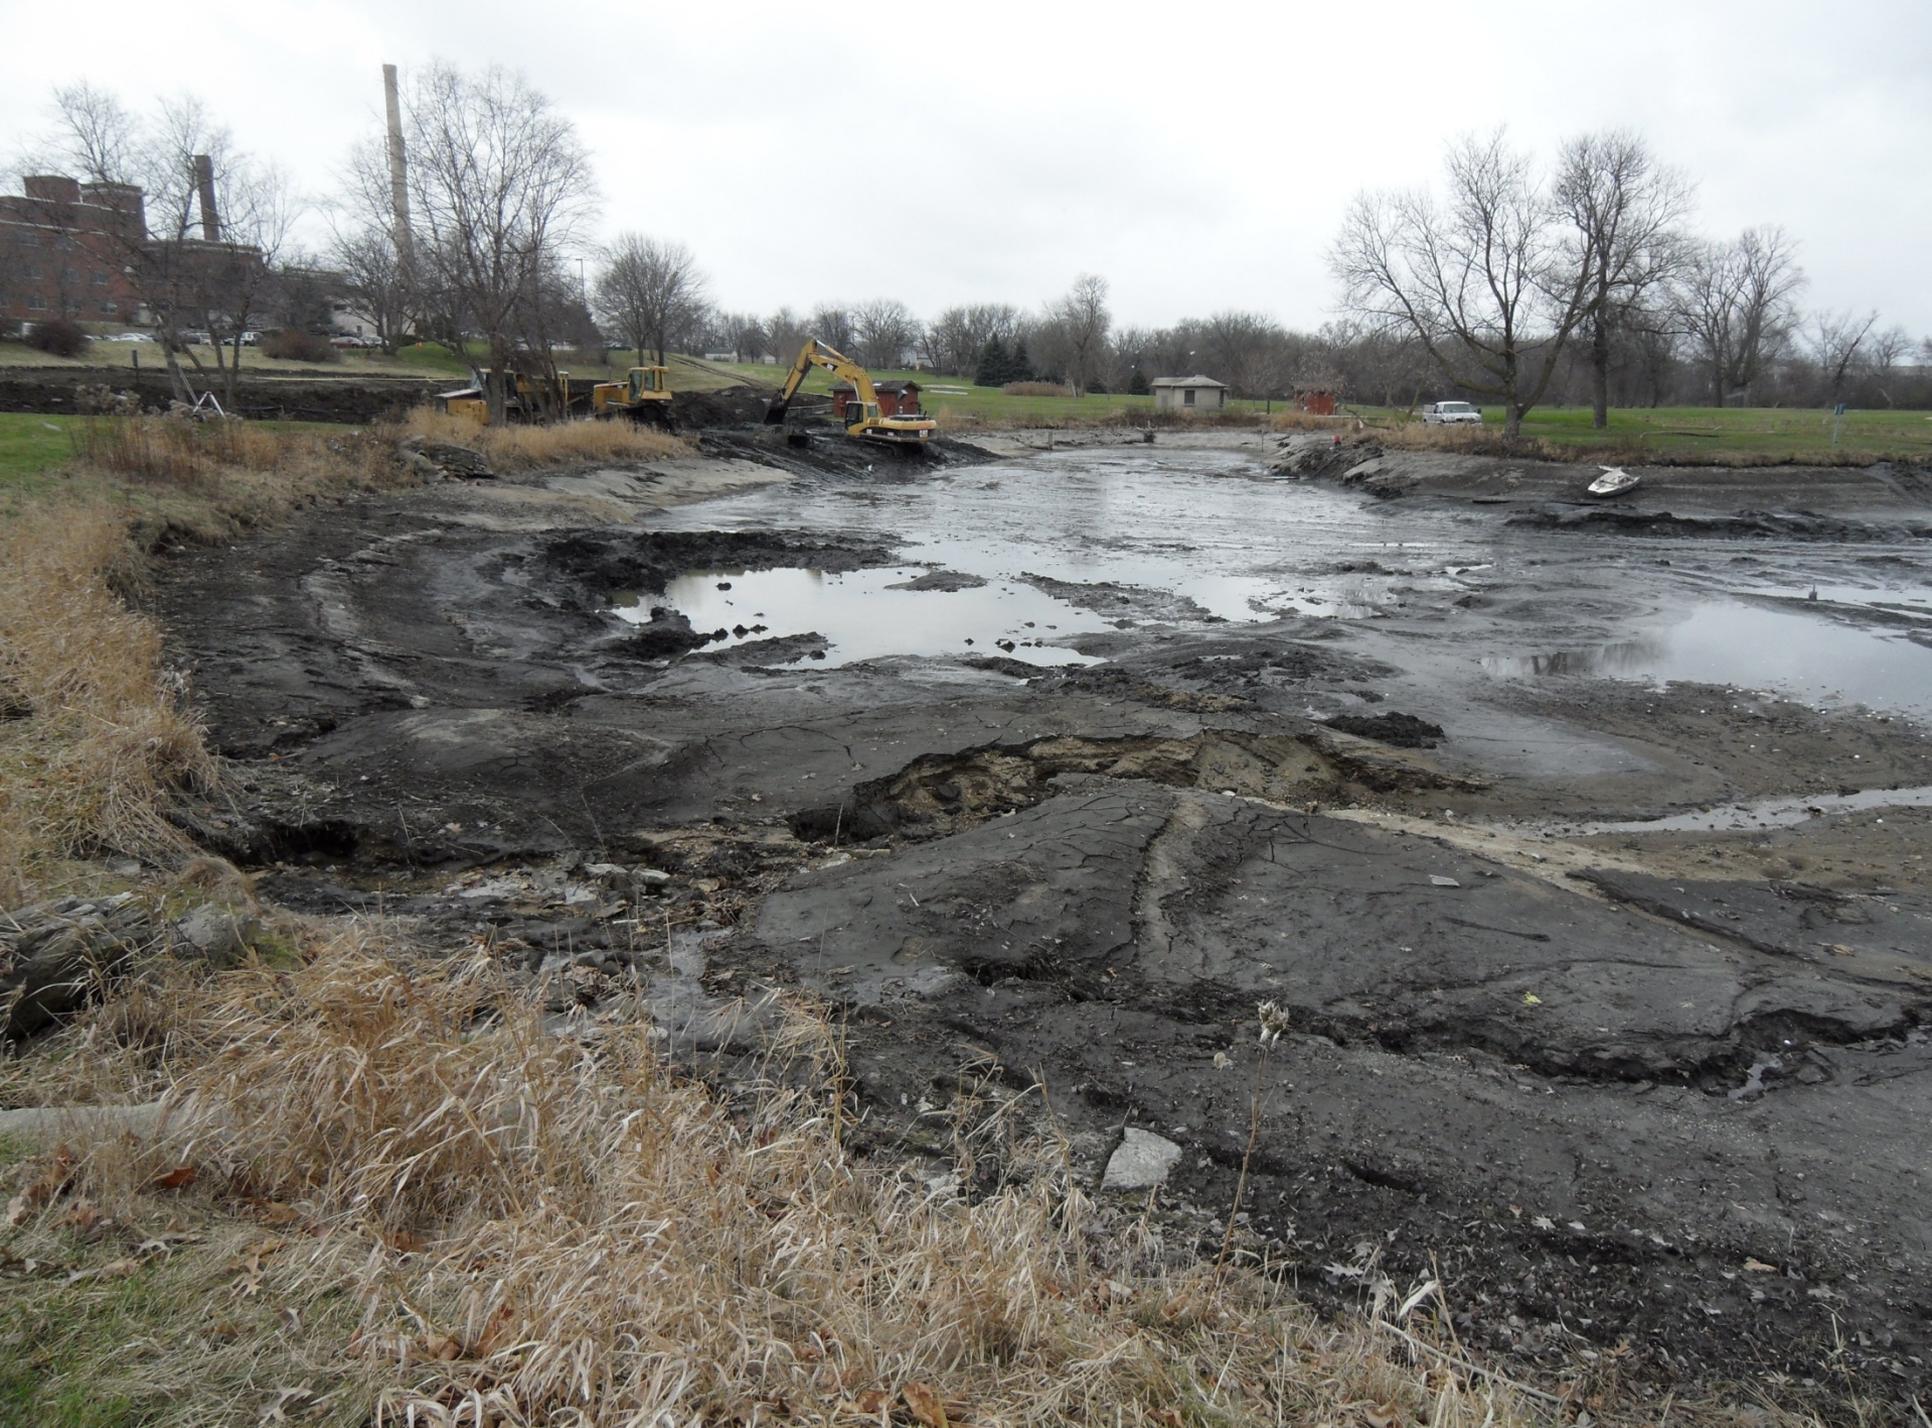
- Golf course closure
- Dewatering did not start until mid-November
- Handling water in single-digit temperatures
- Frozen soils
- Snow
- Restoration issues

- Evaluate soils and water table in plan phase
- Oversize dewatering BMPs
- Dredge spoils are very liquid.
 - Cannot pile up or move off-site.
 - Important to provide for spoil staging areas in development plans.
 - Hydraulic excavation could address the expansive spoils area

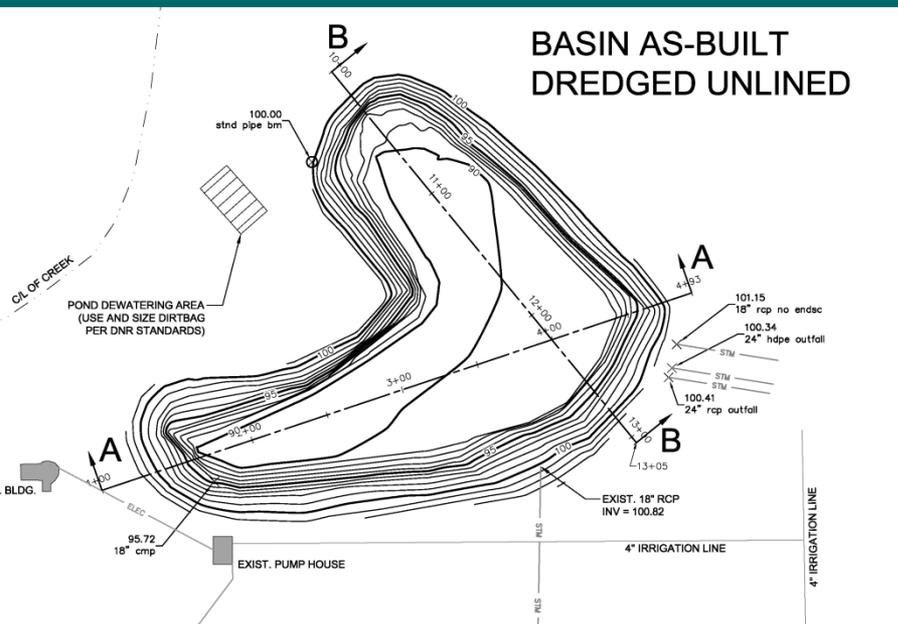
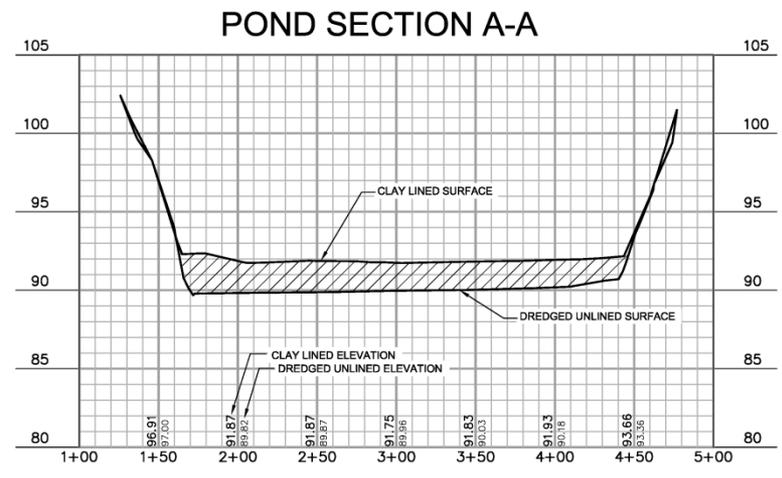
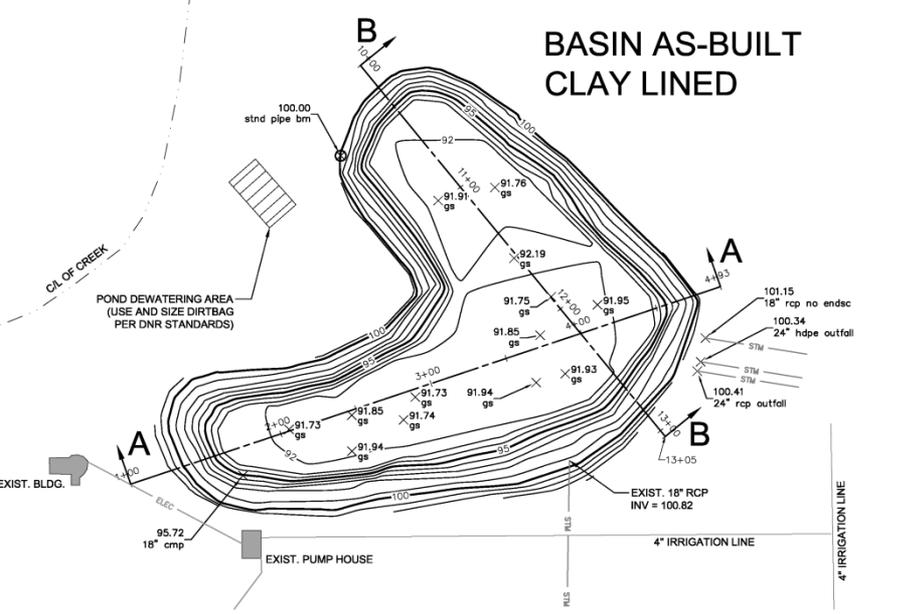
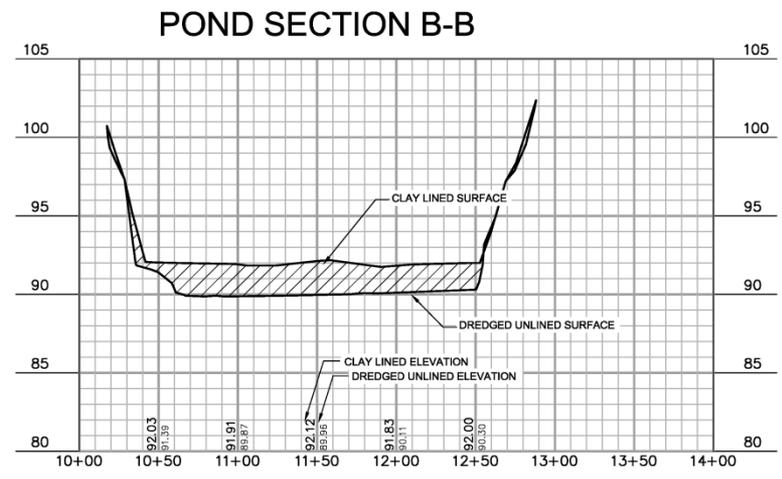
As built survey / cross sections

- Used to evaluate liner thickness
- Record for future reference

MOOR DOWNS GOLF COURSE POND
AS-BUILT CROSS SECTIONS
WAUKESHA CO. #2009-MD 01
CITY OF WAUKESHA, WISCONSIN

- After de-watering, must prepare for infall erosion
- Important to verify liner thickness. Survey data?
- Keep as-built records for future reference
- Verification of material specs, compaction
