2021 Waukesha County Stormwater Workshop

Ecological Restoration of Stormwater Infrastructure in the UW-Madison Arboretum (2000-2020)

Jon H. Lindert, P.E., LEED AP, Strand Associates, Inc.®

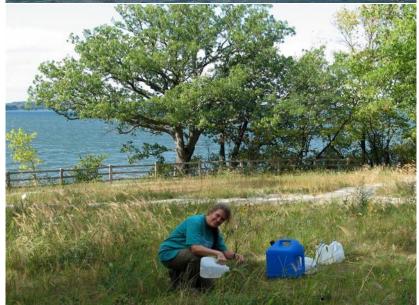
Angler's Cove Prairie and Bluff Restoration (2003)

Before After

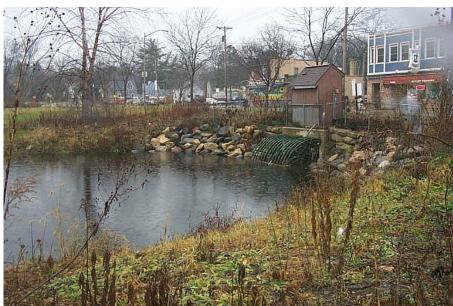
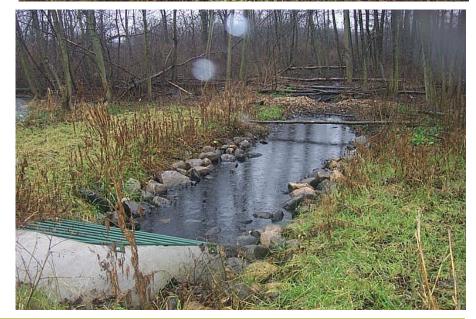
Marion-Dunn Pond Dredging and Rehabilitation (2003)

Before After

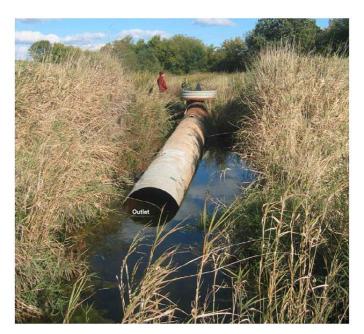
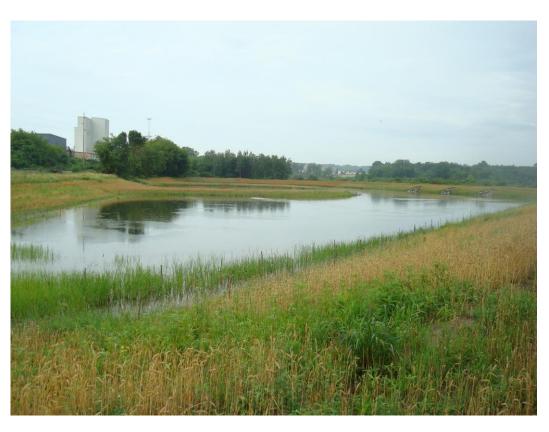
Pond 4 Dredging and Rehabilitation (2009)-Before

- No forebay
- No safety shelf
- Undersized
- Topsoil Berms
- Corroded CMP
- 2.3 feet of sediment

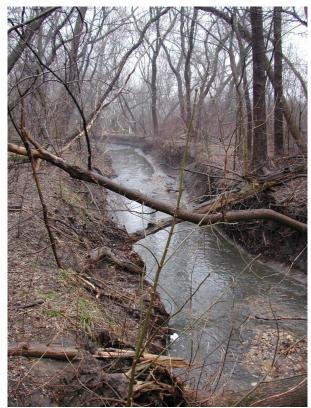
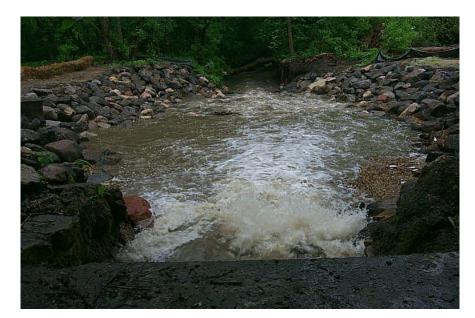
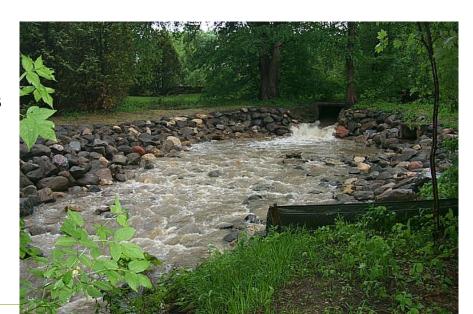
Secret Pond and Channel Rehab (2011)-2003 Dissipater

- Q100=434 cfs
- **Q50 367 cfs**
- Q25=308 cfs
- Q25=4.5 fps

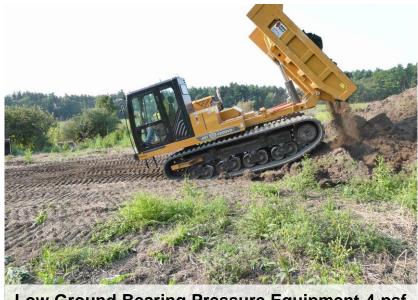
Low Ground Bearing Pressure Equipment-4 psf

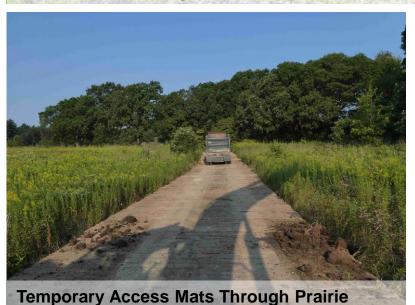
Herbicide Twice, Then 6" to 10" Depth Scrape

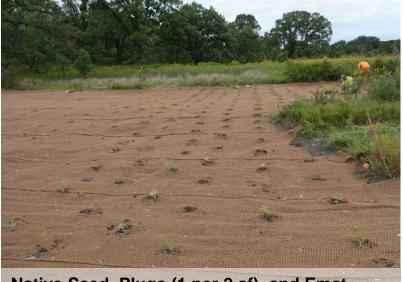
Native Seed, Plugs (1 per 2 sf), and Emat
