# Streambank Stabilization and Water Quality Trading for MS4 TMDL Compliance

Nick Hayden – EOR

Leif Hauge - Waukesha County LRD

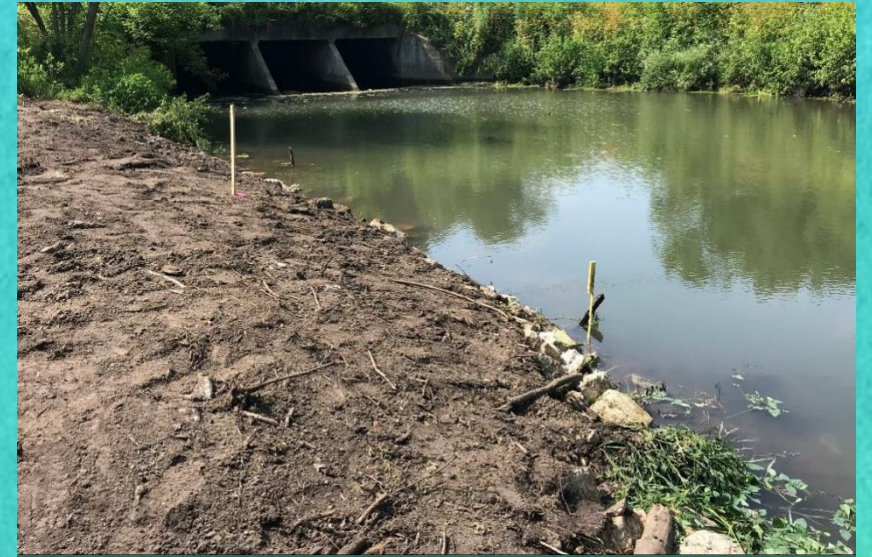
Vegetated Boulder Toe w/ Bank Grading

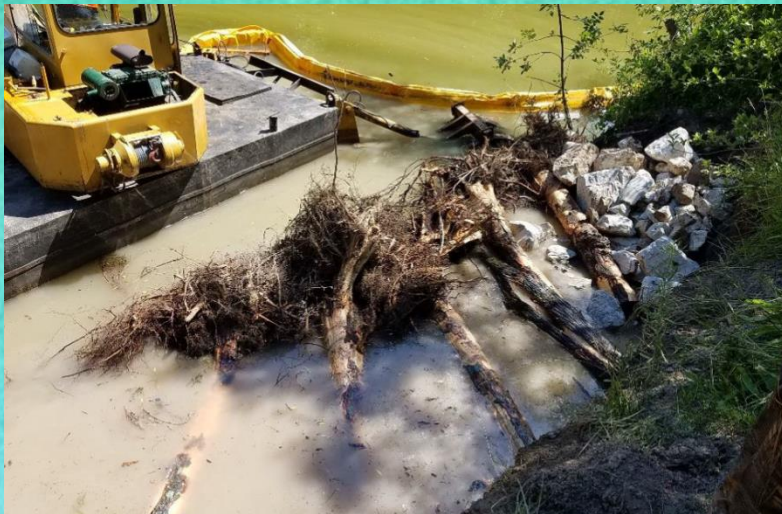
Rootwad w/ Stone Revetment

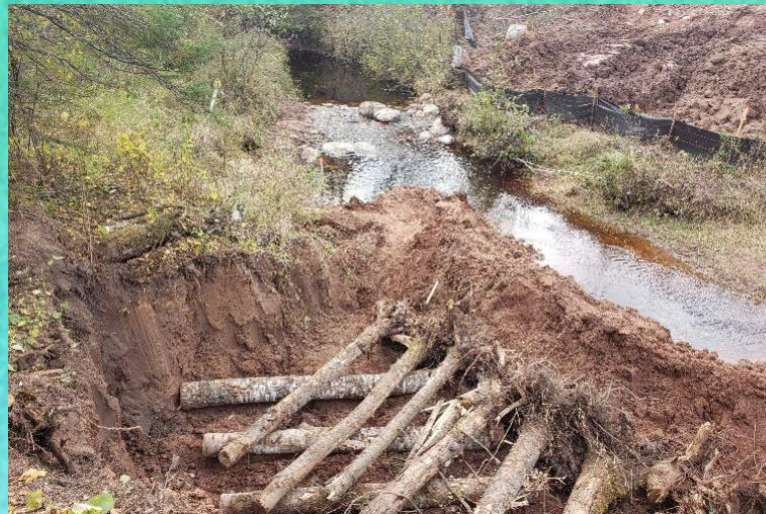
Toewood (pre-brush)

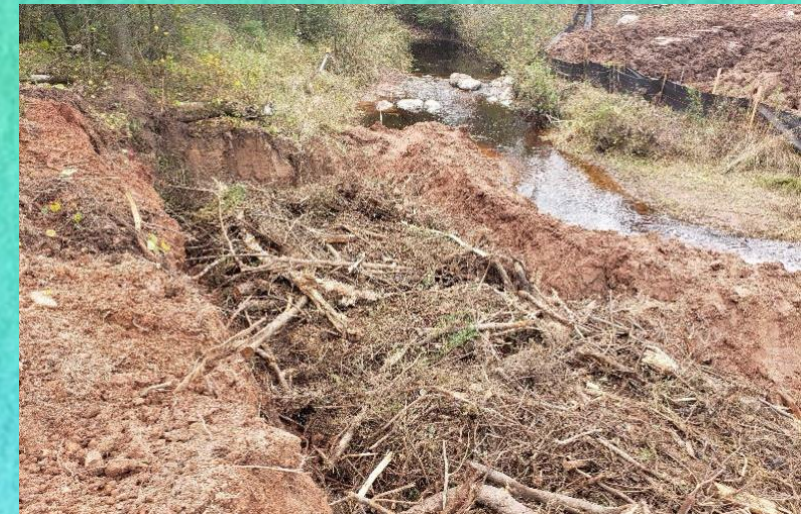
Toewood (brush cover)

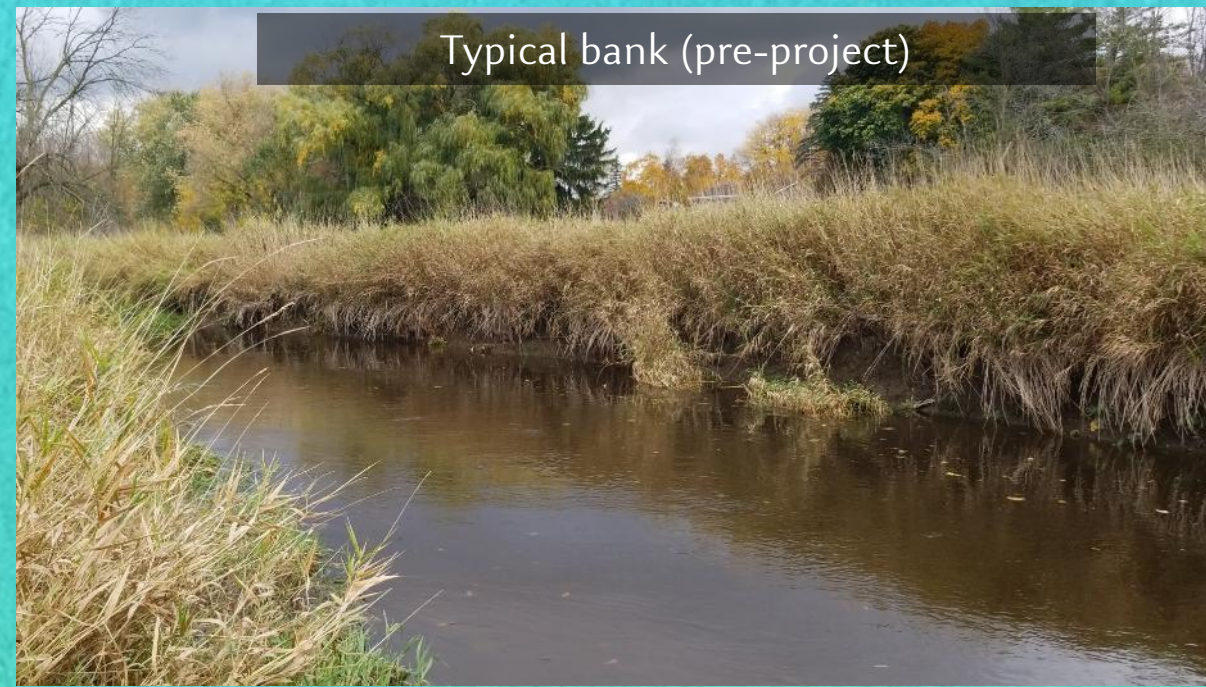
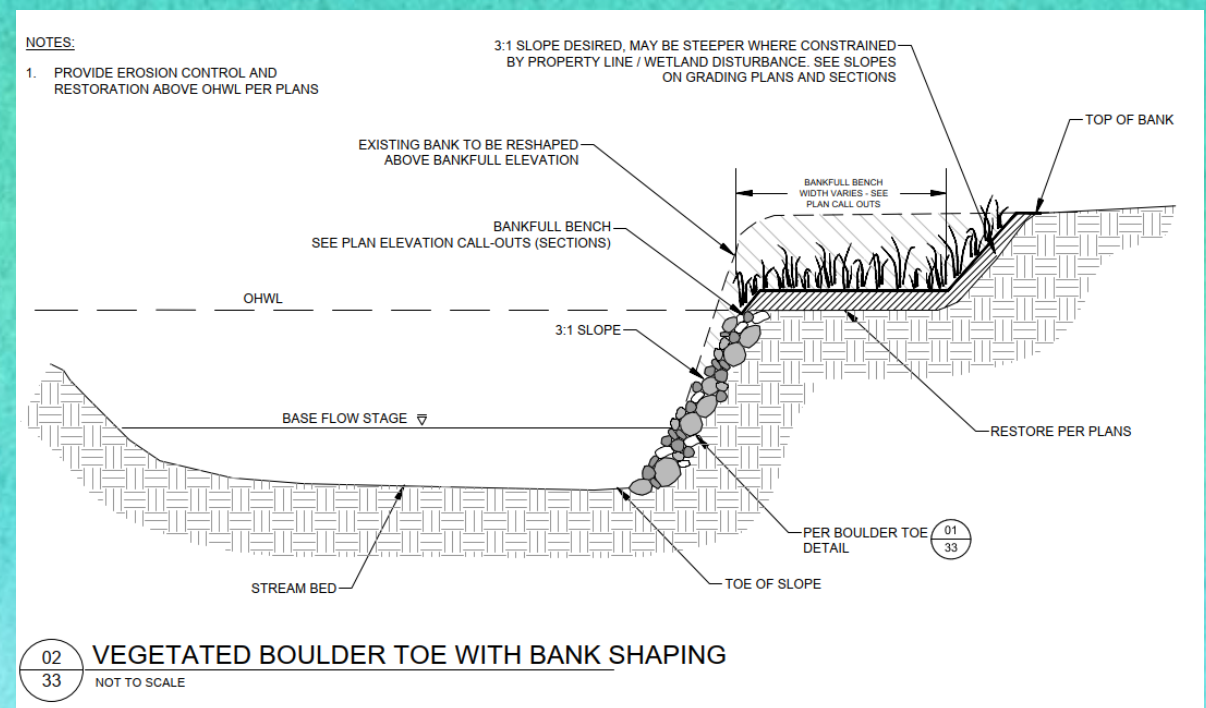
# Rotary Park (Menomonee River)

- 500 LF of vegetated boulder toe with 5-10' floodplain benching at OHWM and 3:1 tie-out grading (3 separate sections)
- 9 rock wing deflectors for habitat credit
- 2 live staking areas on opposite bank for improved habitat and erosion resistance
- 1 area with native vegetative mat (beyond typical native seed restoration)
- 2 sets of fishing/access steps

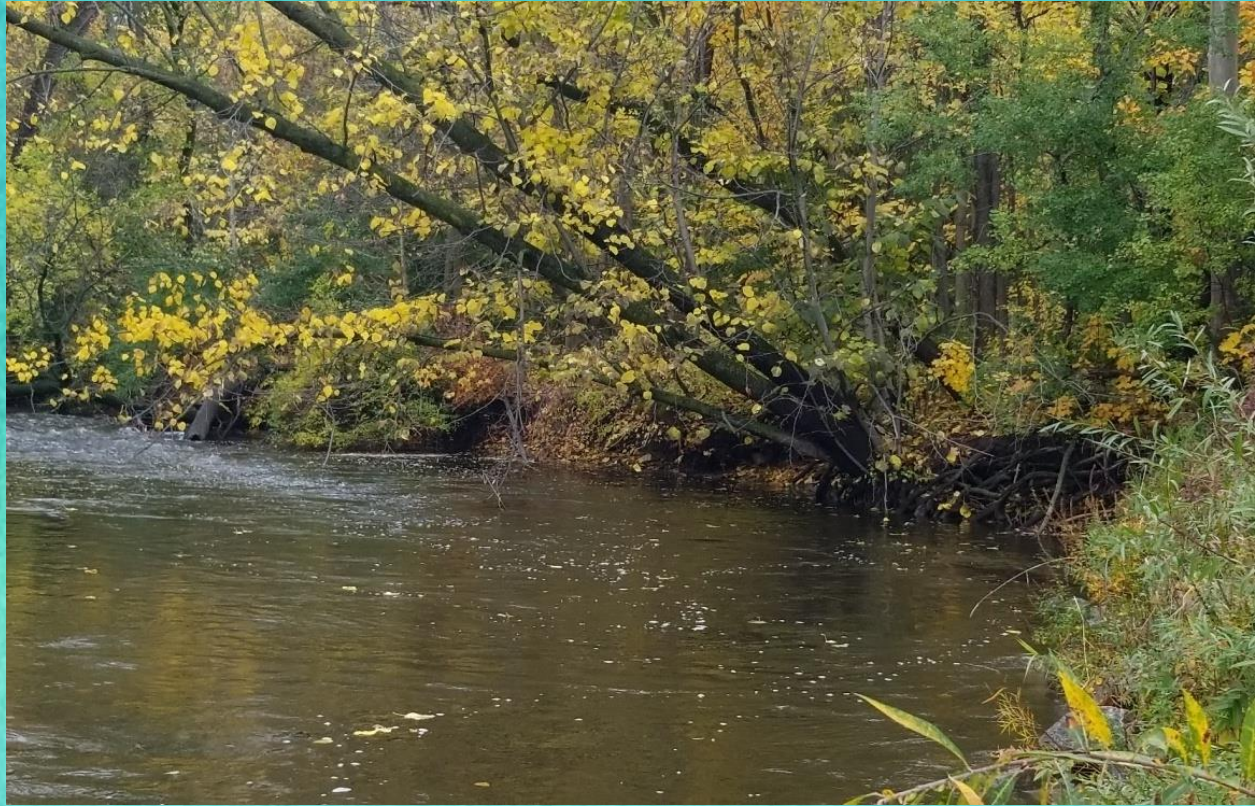
Failing bank and scour pool

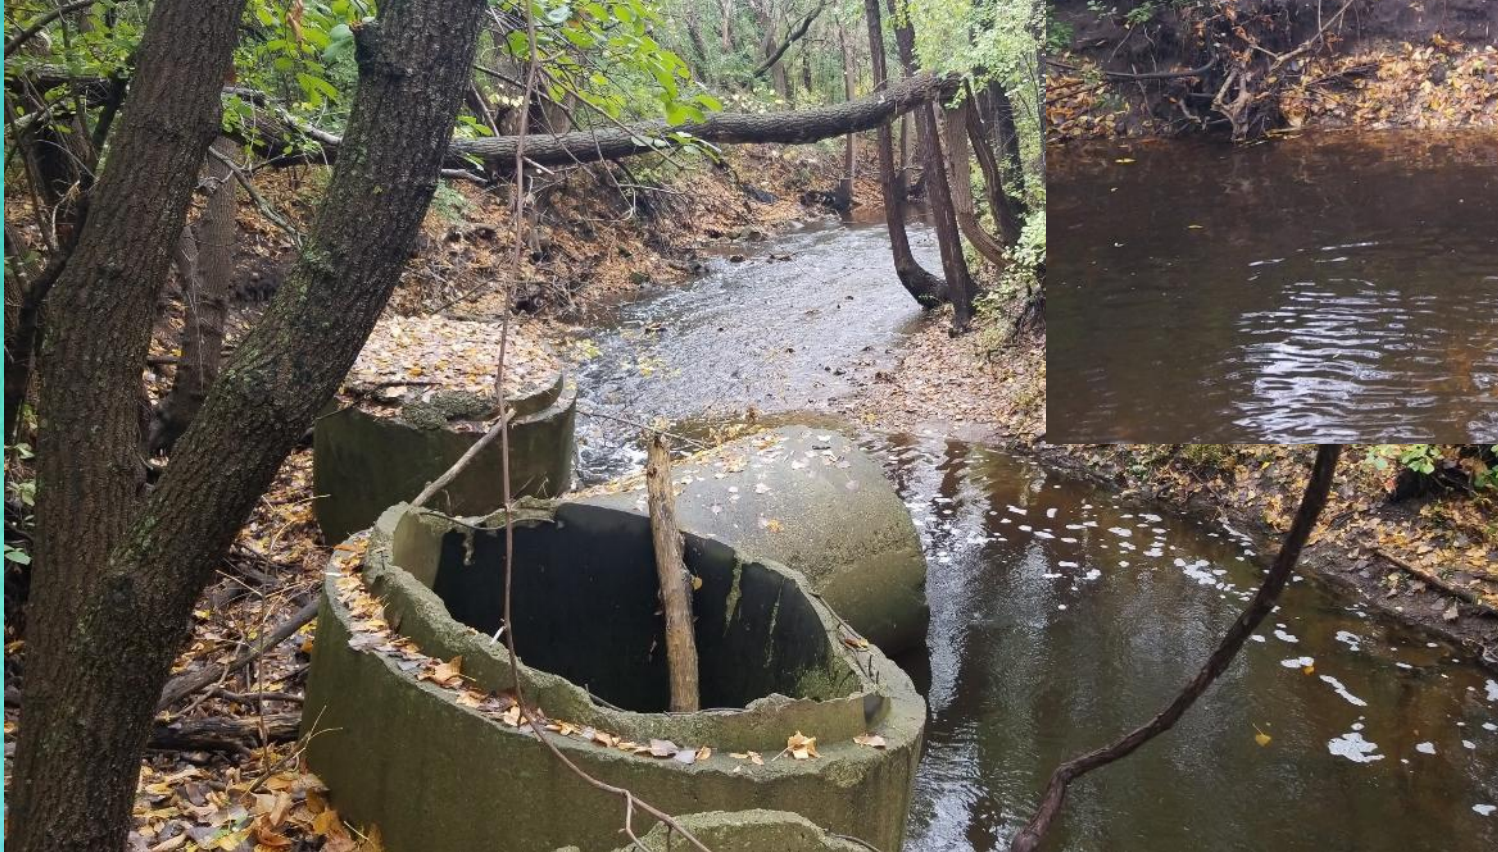
Failed revetment

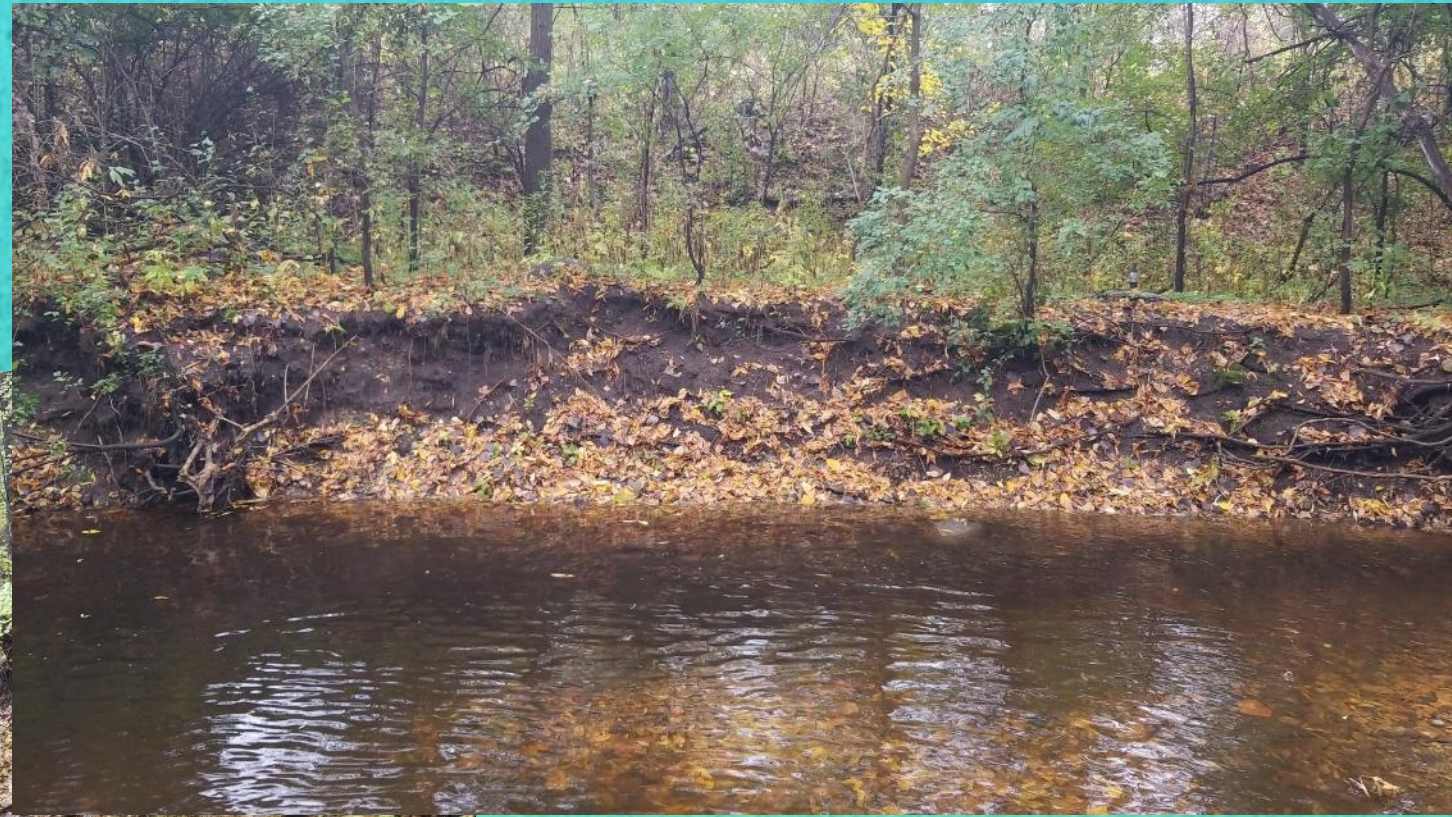
Steep failing banks

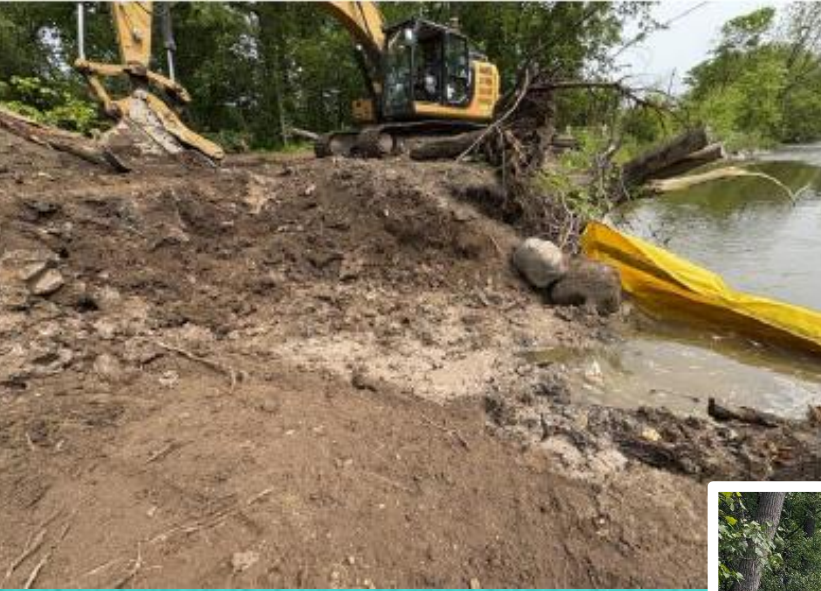
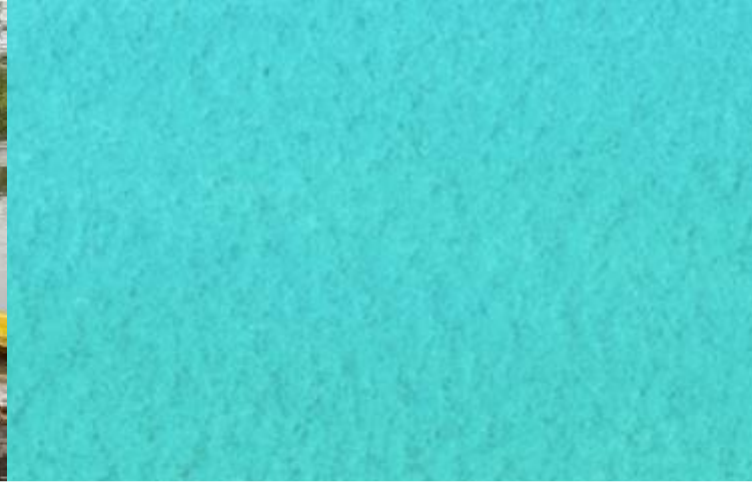
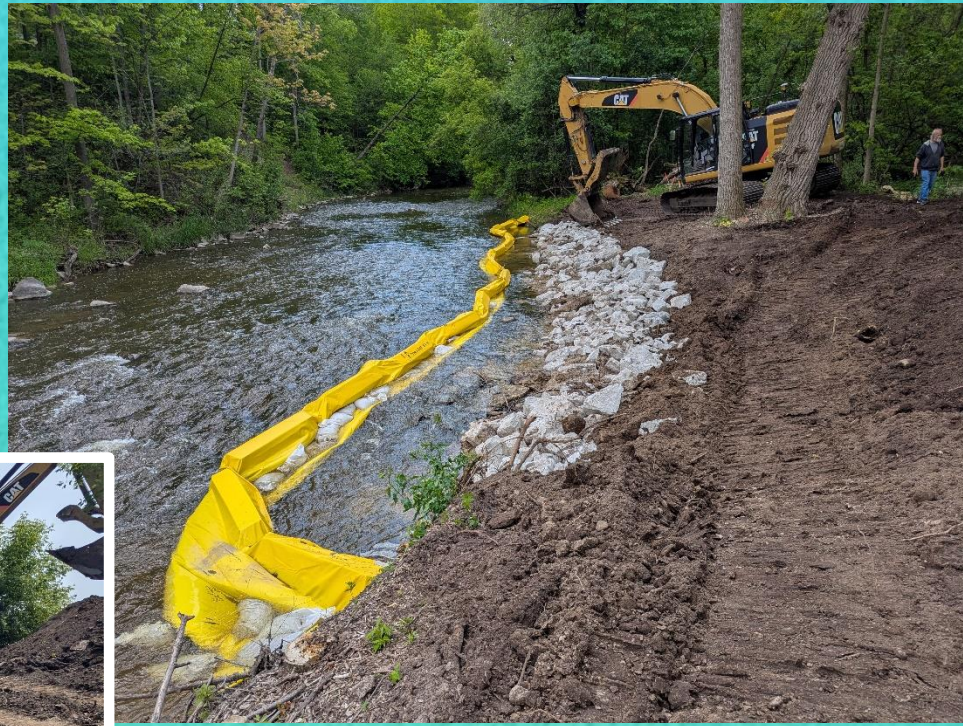
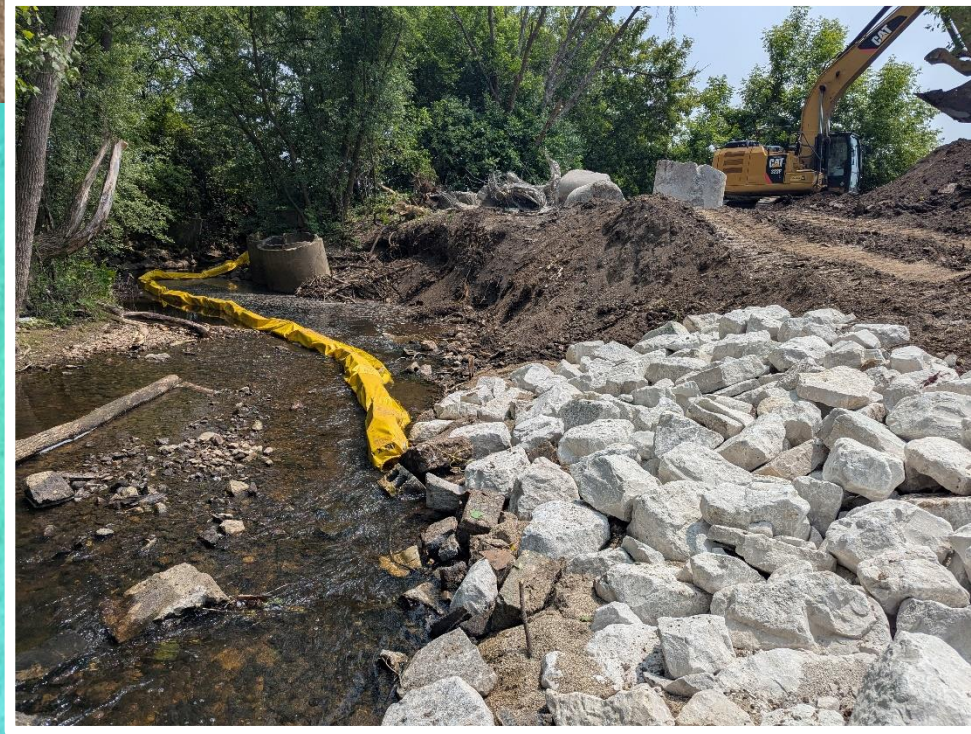
Contractor  
completed 75-100  
ft/day
