CTH BB (US-18 to CTH DR) Public Involvement Meeting Village of Summit, Waukesha County November 19th, 2025

Project Snapshot

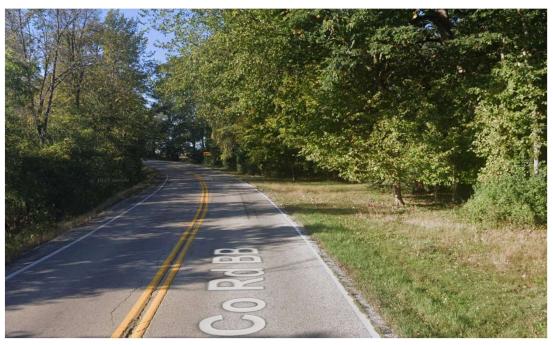
Near 883 N Golden Lake Rd - Southbound

- Pavement Condition
- Crash History
- Sub-standard Road
 - Cross-section
 - Vertical/Horizontal Profiles
 - Intersection Geometry

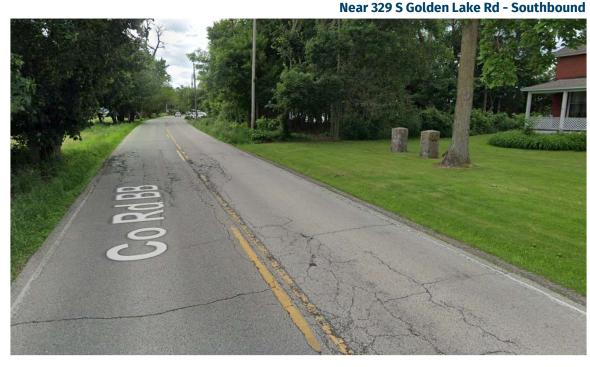
- Alligator Cracking
- Transverse Cracking
- Longitudinal Cracking (Wheelpath)

- 55 (2020)
- 46 (2023)
- 44 (2025)

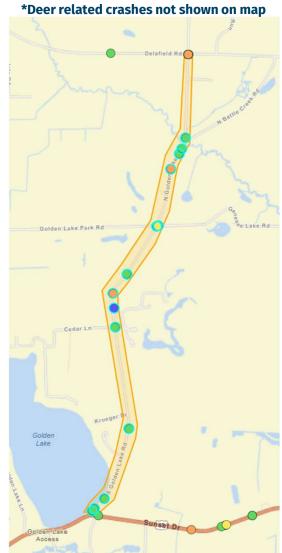
- 14 Total (Non-Deer)
- 4 With Injury (KABC)

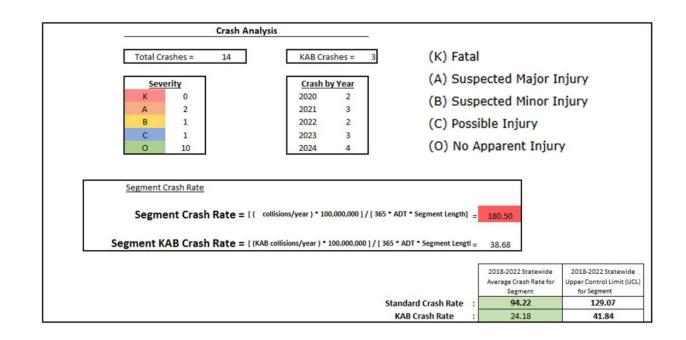
Segment Crash Analysis on CTH BB

- Segment crash rate almost double the statewide average
- Segment also above the KAB

(injury related) crash rate, but

under the upper control limit.

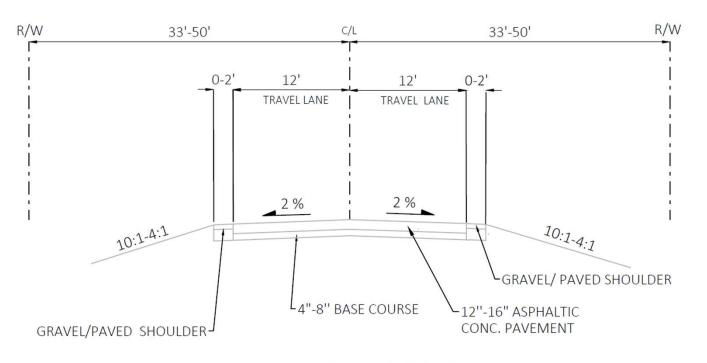
Typical Existing Cross Section

EXISTING TYPICAL SECTION S GOLDEN LAKE RD (CTH BB) 35 & 50 MPH

Test Boring Location	Surface Asphalt- Concrete Layer Thickness (inches)	Base Course Thickness (inches)
1	±5½ (+10 in. Asp.)*	±4
2	±4 (+13 in. Asp.)*	±8
3	±6 (+10 in. Asp.)*	±4
4	±4 (+10½ in. Asp.)*	±6
5	±6½ (+9 in. Asp.)*	±4½
6	±4 (+12 in. Asp.)*	±4
7	±5 (+9½ in. Asp.)*	±6
8	±4½ (+9½ in. Asp.)*	±12
9	±4 (+10 in. Asp.)*	±8
10	±4 (+8 in. Asp.)*	±6

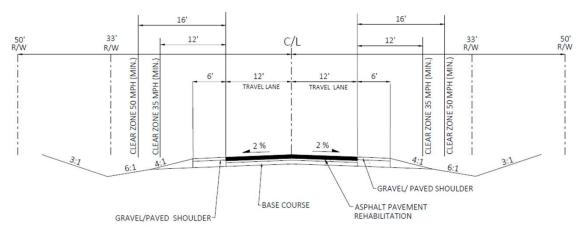
ALTERNATIVE 1 TRANS 205.025 STANDARD DESIGN

- Pavement rehabilitation along corridor
- Highway cross culvert replacement (as-needed)
- Add wider shoulders
- Remove trees and vegetation (sight, clear zone)
- Rumble strip inclusion (Centerline and/or Shoulder)
- Additional signage (i.e. curve ahead, advisory speed, & chevrons)

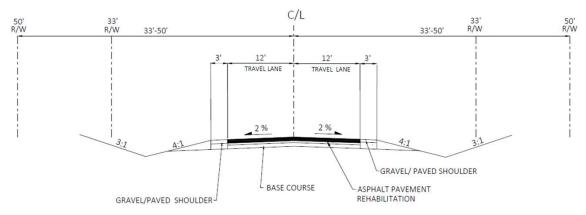
REDUCED IMPACT ALT.
