EROSION CONTROL AND EXTREME WEATHER EVENTS

Types of Extreme Weather Events in Wisconsin

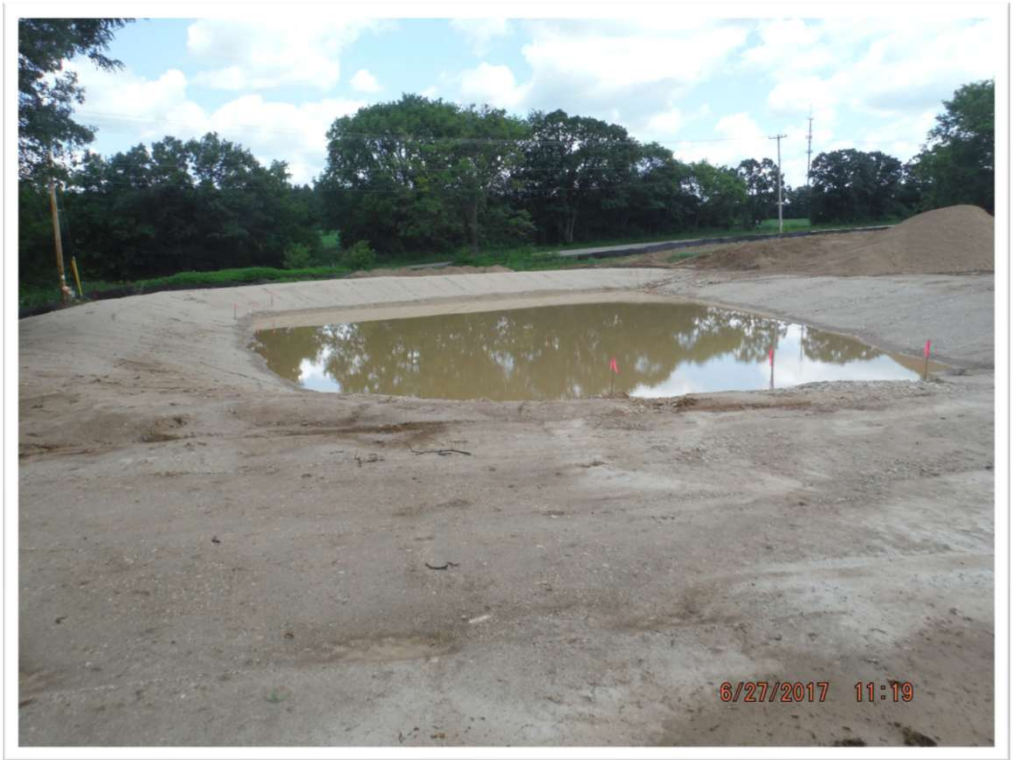
June 27th, 2017 Weekly Inspection

name of Permittee: XXXXX		Construction Site ID No.: XXXXX	
Construction Site Name (Project): XXXXX			
Exact place of erosion/sediment control inspected	Type of erosion/sediment control and its observed condition	Description of any necessary maintenance or repair to erosion/sediment control, including anticipated date of completion	
1. North and south sediment basins. See item #1 in photos below.	Out of sequence- Sediment basins are not complete. The primary and secondary outlets are not installed. Sediment basins are not stabilized.	Complete construction of the sediment basins prior to land disturbing activities as per Construction Schedule #4 found on plan sheet C001. Follow plan details and DNR Technical Standard 1064. Note- Grading of the adjacent cul-de-sac and roads were occurring at the time of inspection.

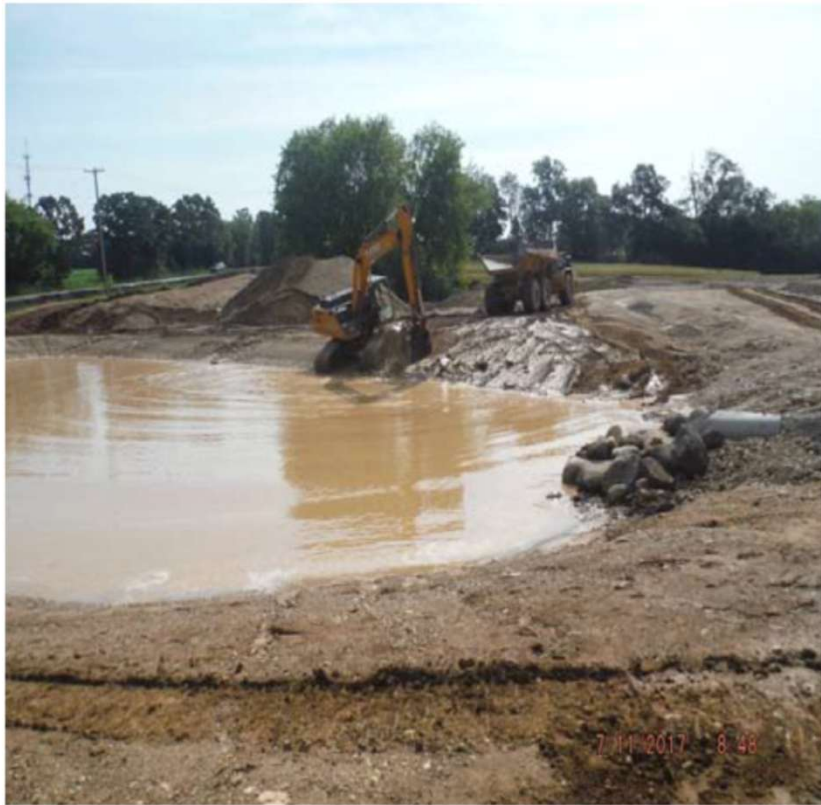
July 10th, 2017 Rain Event

BASIN CONSTRUCTION NOTES:

1. BASIN TO BE OVER-EXCAVATED 4 FEET. THIS AREA IS TO BE USED AS A SEDIMENT CONTROL DEVICE DURING CONSTRUCTION. CONTRACTOR TO STORE APPROPRIATE MATERIAL ON-SITE TO BE USED TO RESTORE OVER-EXCAVATED AREA (MATERIAL MUST BE PERMEABLE TO BE APPROPRIATE). IF MATERIAL IS NOT APPROPRIATE, OR NOT ENOUGH IS FOUND ON-SITE, ADDITIONAL MATERIAL WILL NEED TO BE IMPORTED.
2. BASIN TO BE RESTORED USING RUBBER TIRED EQUIPMENT ONLY. FILL OVER-EXCAVATED AREA ONLY WITH MATERIALS THAT MAINTAIN THE GROUND'S NATURAL INFILTRATION CAPACITY. INSTALL COMPOST MATERIAL ON TOP OF FILLED AREA AS NOTED BELOW.
