Storm Water BMP inspections and outreach to Homeowners Associations

Leif Hauge and Jayne Jenks

Waukesha County Department of Parks and Land Use

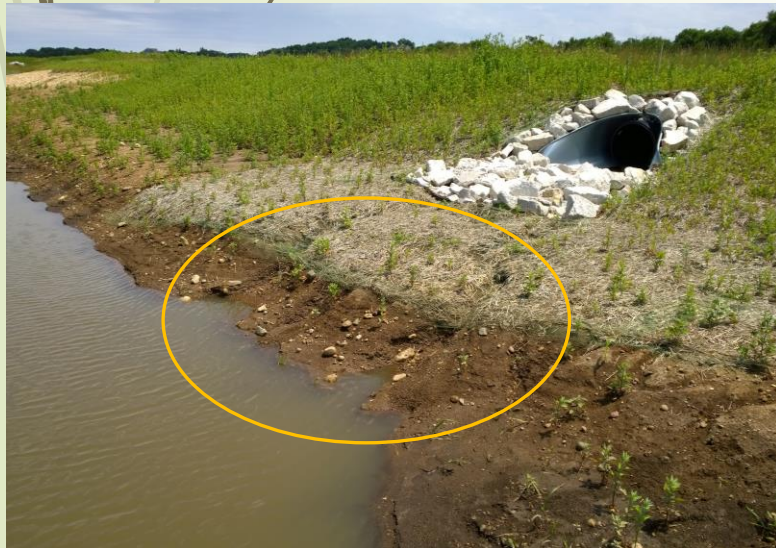
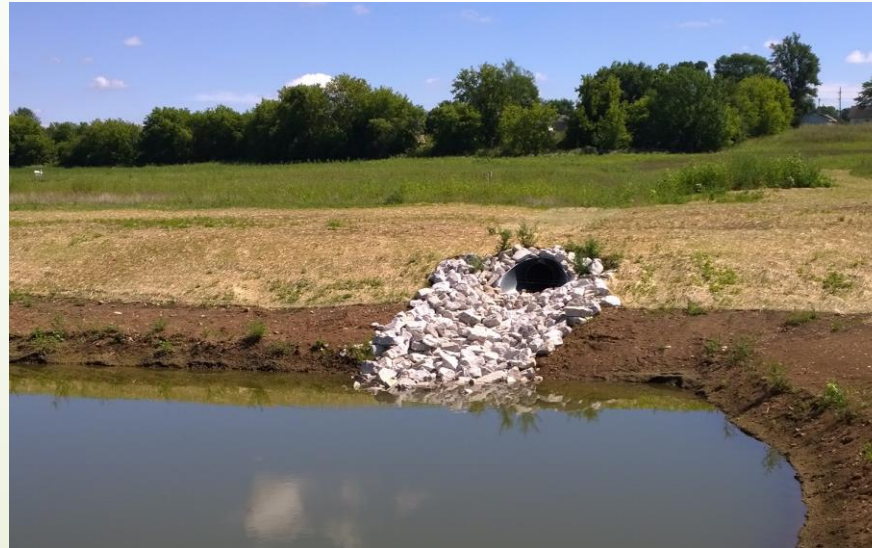
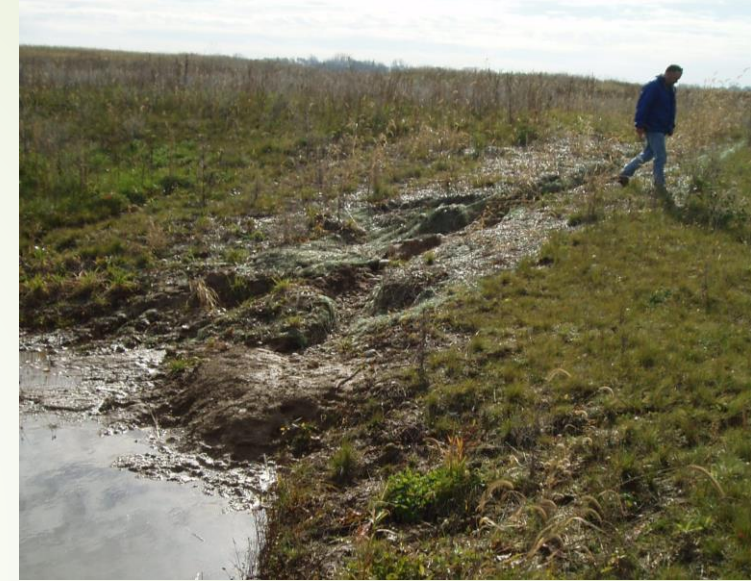
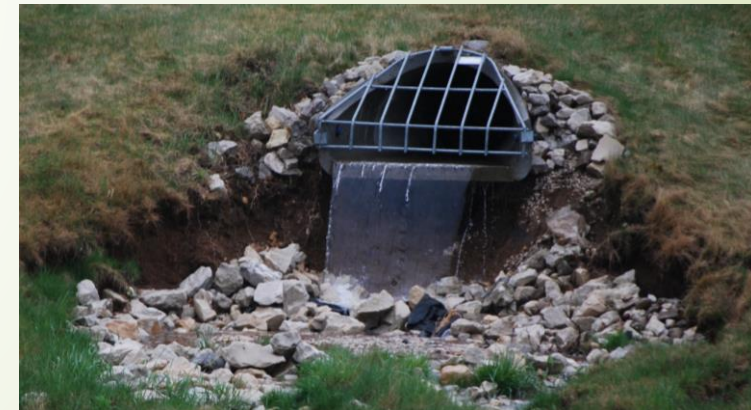
Common Erosion Issues

► Scour

- Around riprap – not channelized – cuts through liner and causes leakage, dropping pool
- Under riprap – no fabric
- Below riprap – not extended far enough (to pond bottom) – water level fluctuation

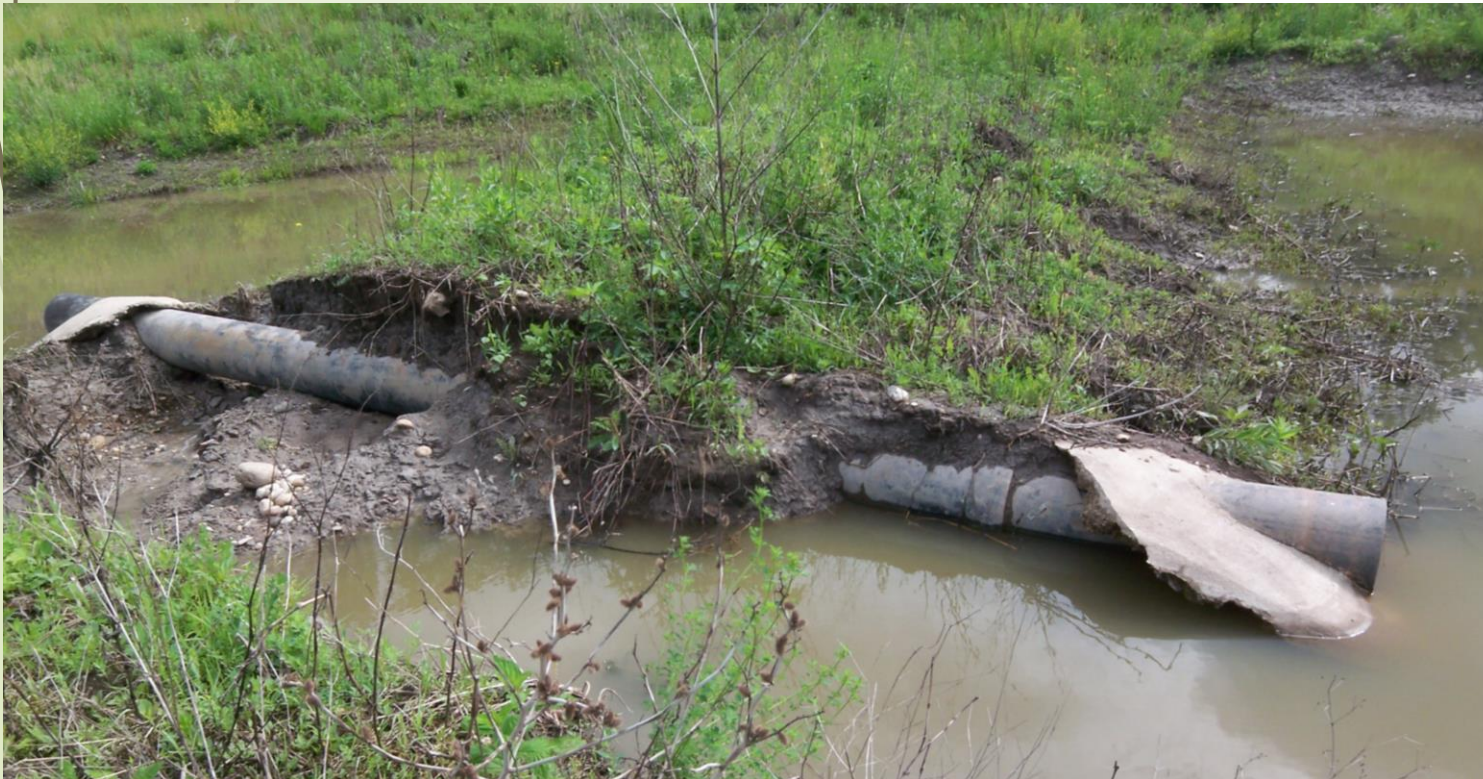
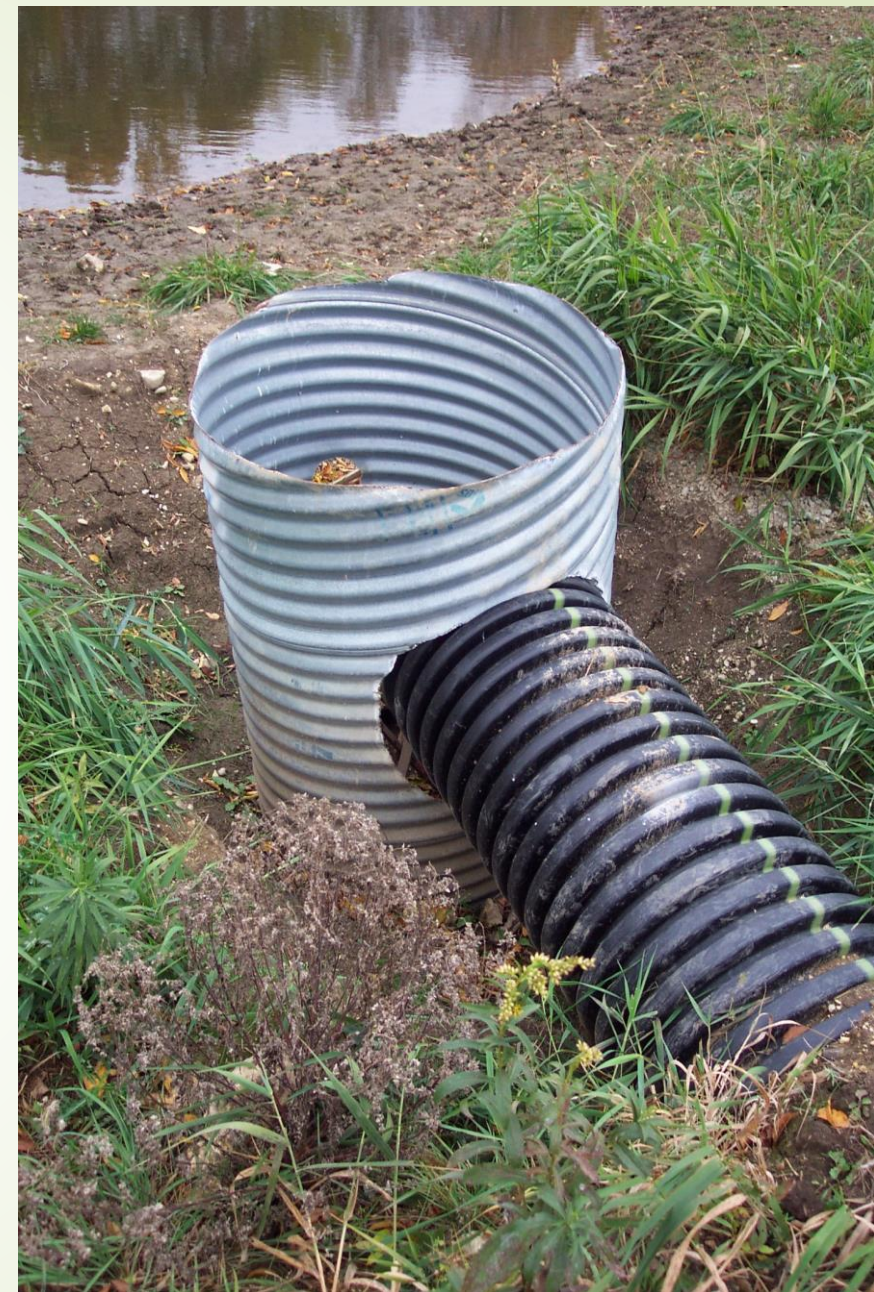
Erosion Issues

- ▶ Around outlet pipes
 - ▶ Piping – no anti-seep collar
 - ▶ Sinkholes / seepage due to gaps in pipes and structures

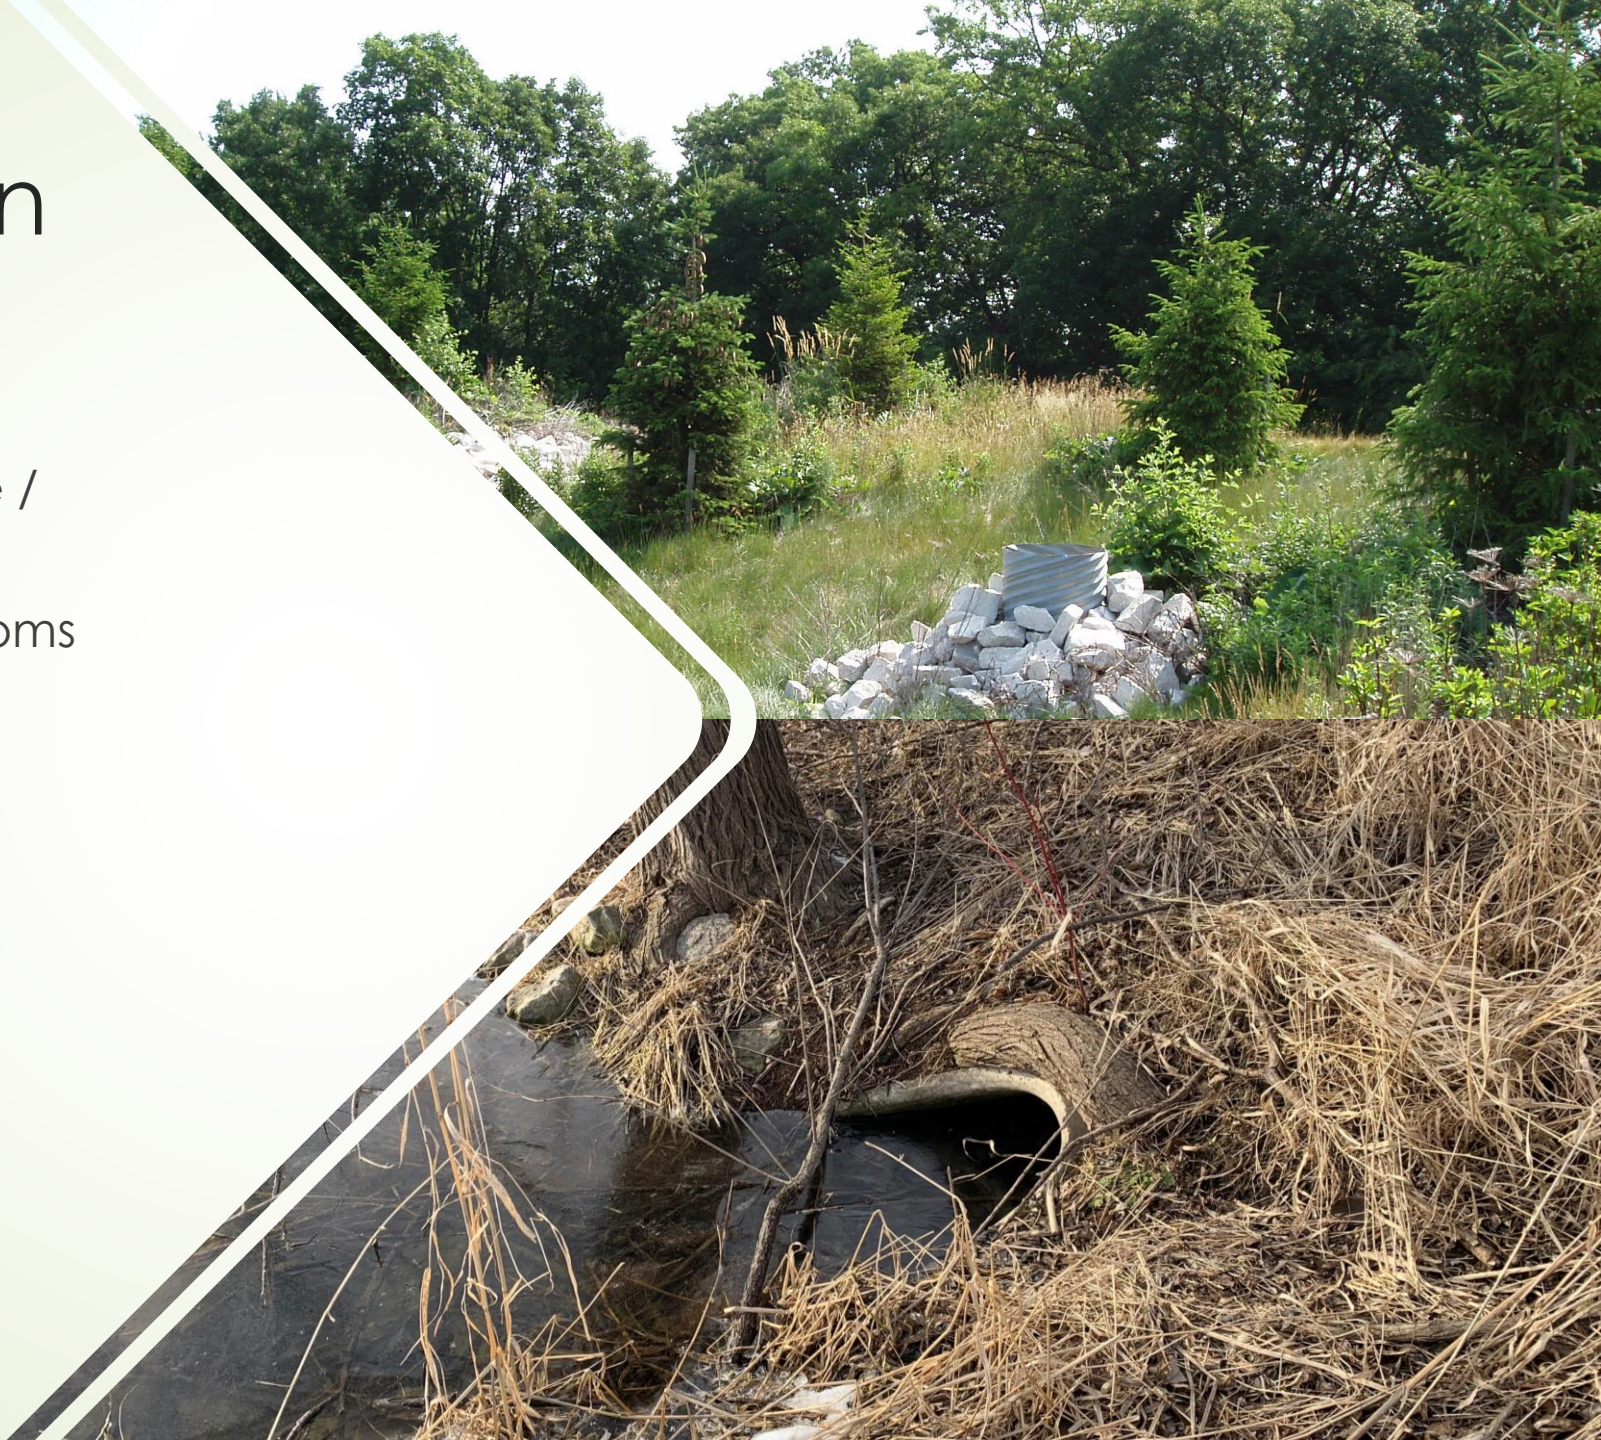
Woody vegetation

- Breaks berm compaction if large / deep enough
- Shades out grasses in basin bottoms
- Obstructs inlets and outlets

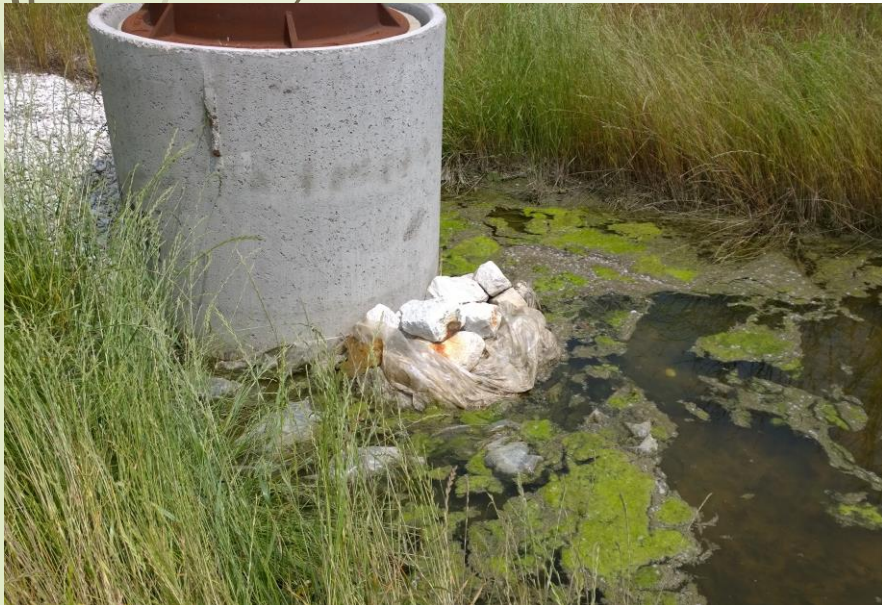
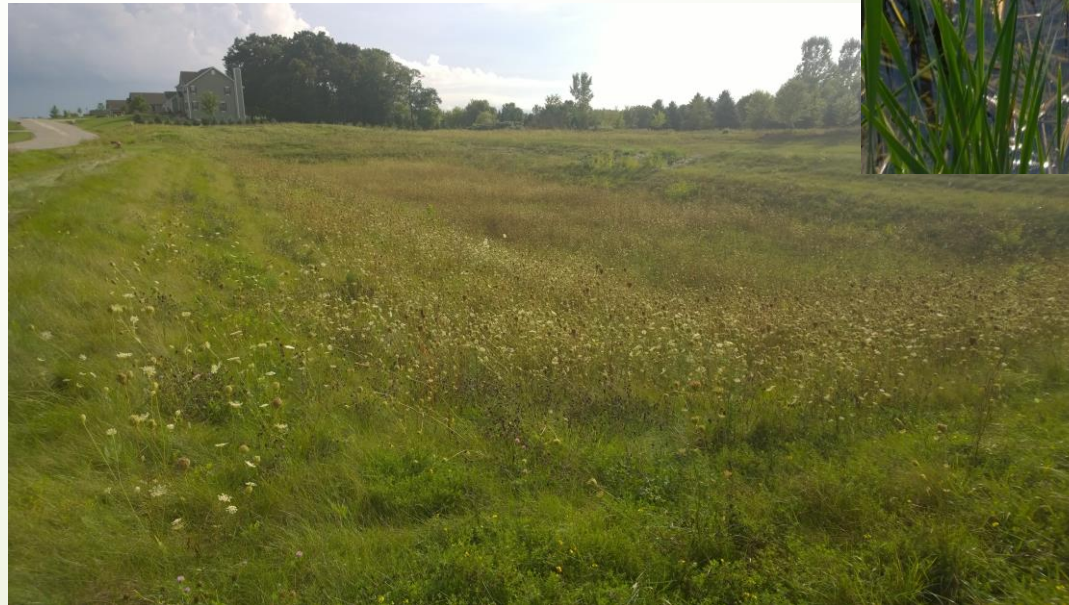
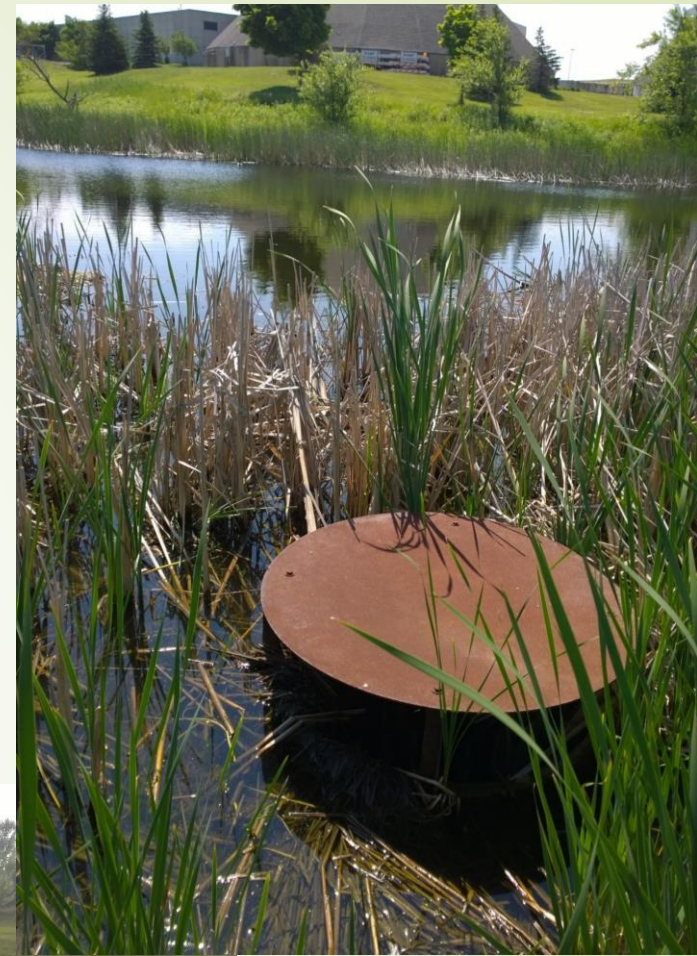
- Pool levels (wet detention)
 - Water level vs design elevation
 - Is safety shelf covered?
 - If not, why?
 - Rain history,
 - leakage,
 - contrib. watershed
 - Is low flow orifice clogged? (high water level)

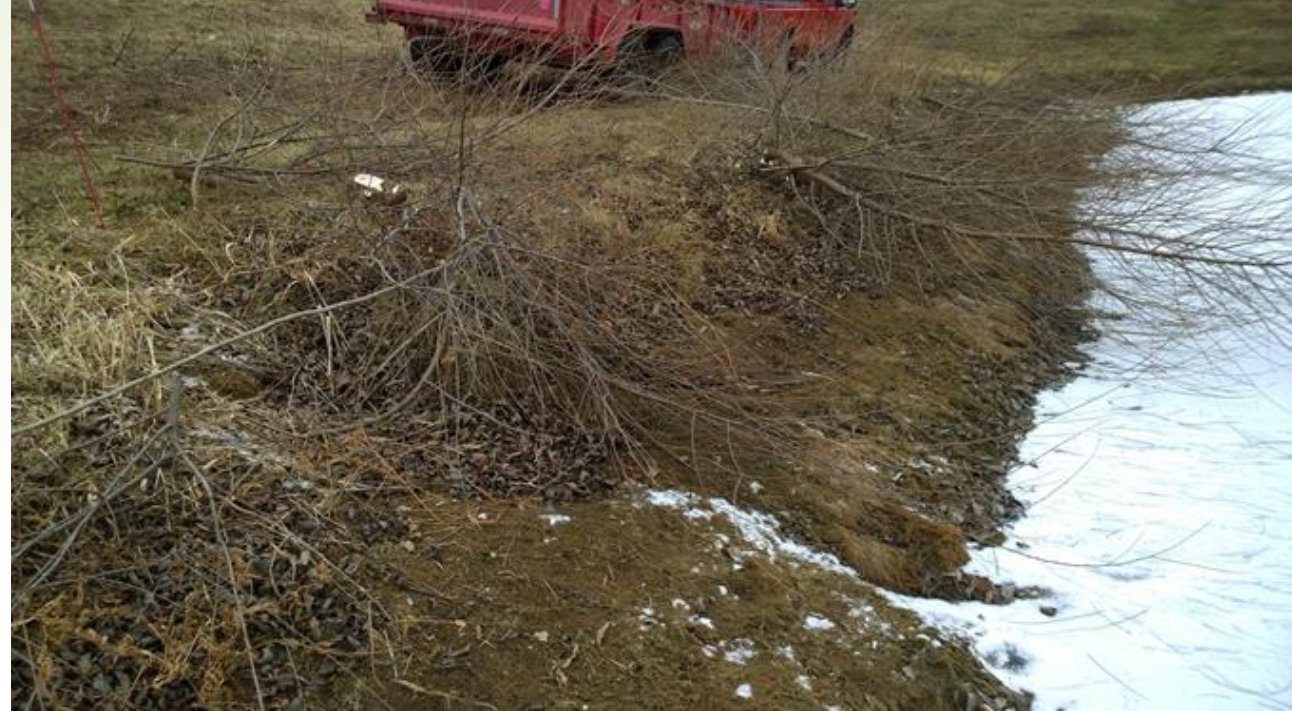
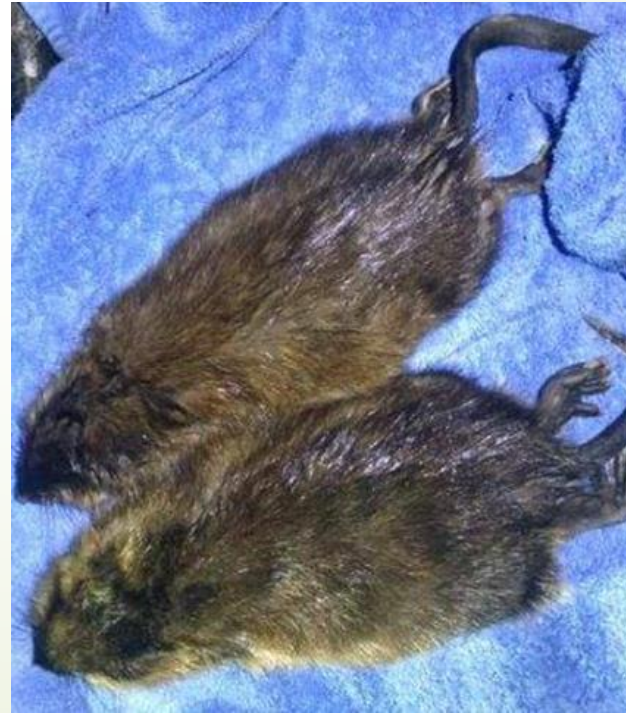
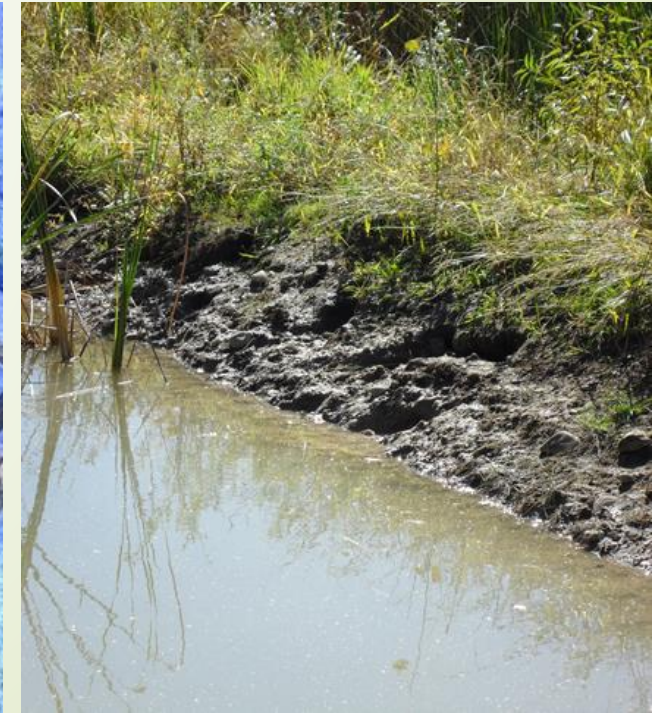
Water

- ▶ Leakage (wet detention)
 - ▶ Scour through liner (see plans for type, design)
 - ▶ Liner slumping due to rise / fall of water table around liner
 - ▶ Punctured plastic
 - ▶ Animal burrows

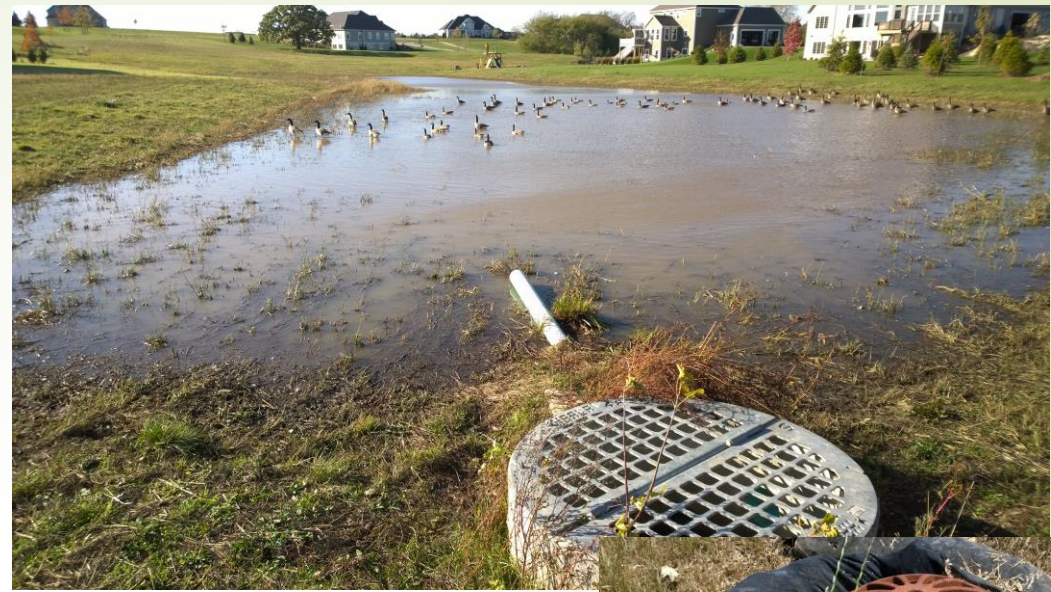
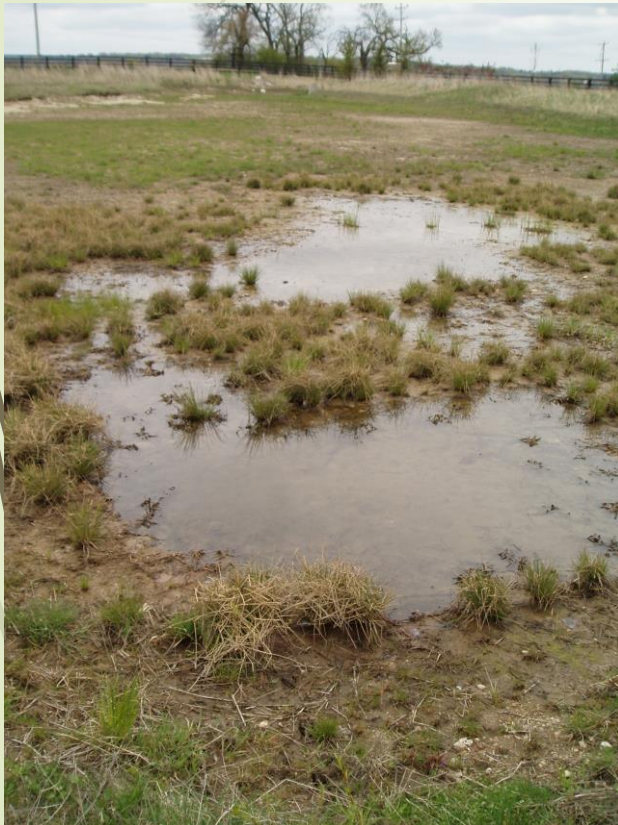
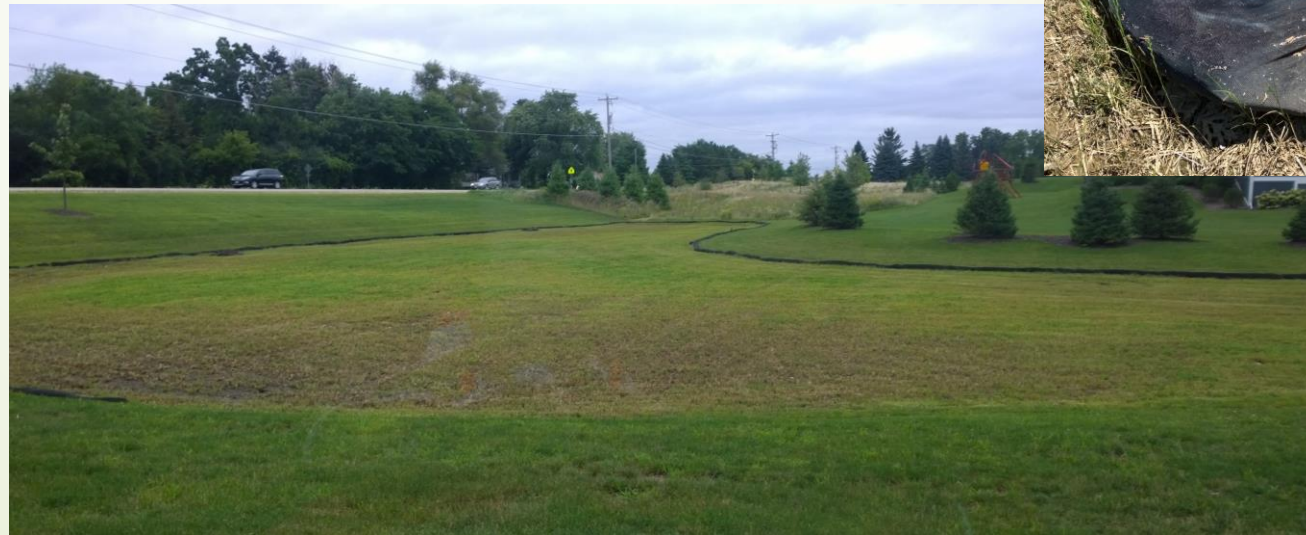
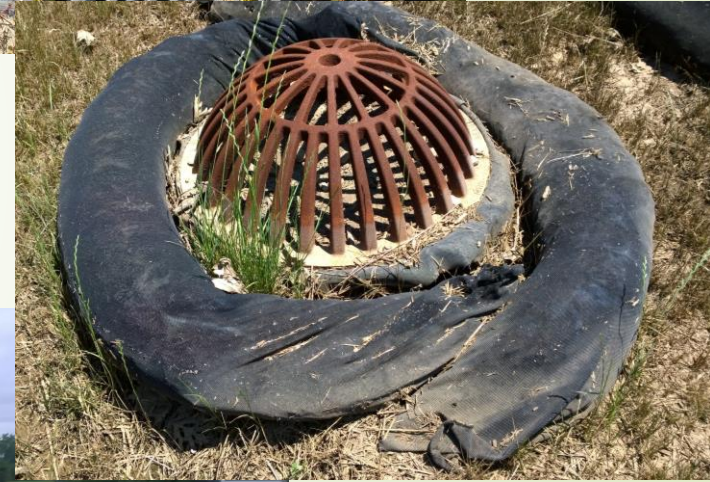
Water

- ▶ Standing water (infiltration, bioretention, trench)
 - ▶ Rain history
 - ▶ Vegetation – stressed, different, cattails, water marks
 - ▶ Observation sump

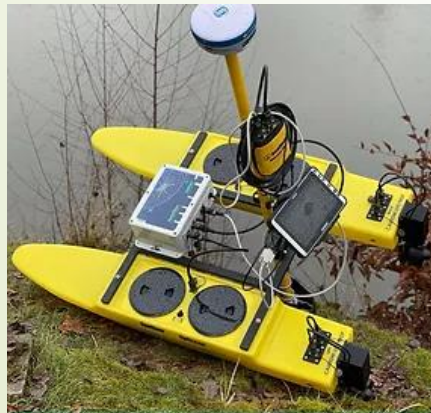
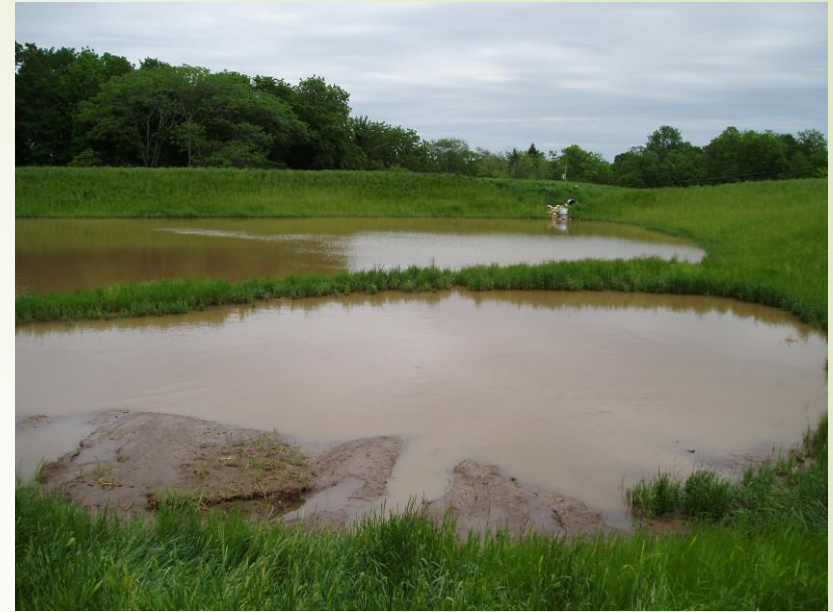
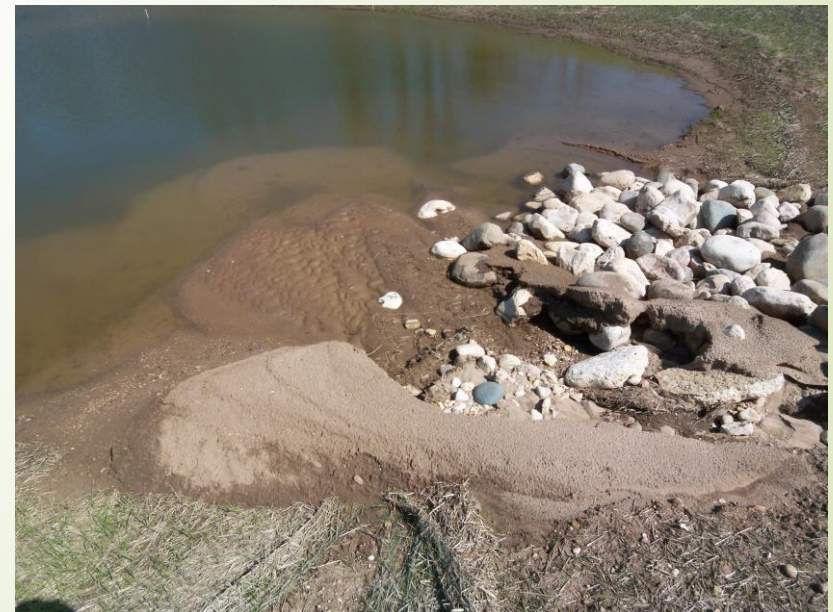
Sediment

- Measure in wet detention with
 - Sebo-meter (fishing rod, sinker, slip bobber),
 - staff + ice auger,
 - drone,
 - Canoe
- Infalls – soil probe, flow obstruction?
- Pre-treatment – trigger for removal?
- Clogging infiltration / bioretention basin bottom?

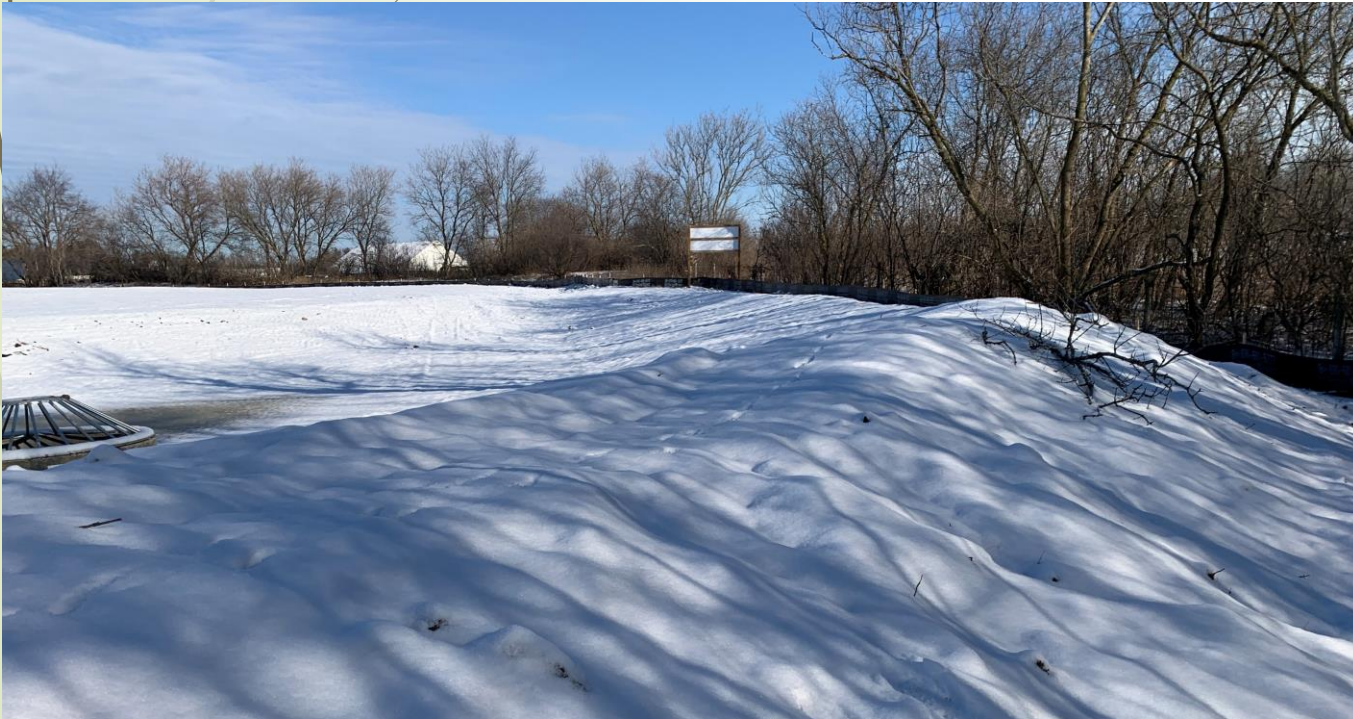
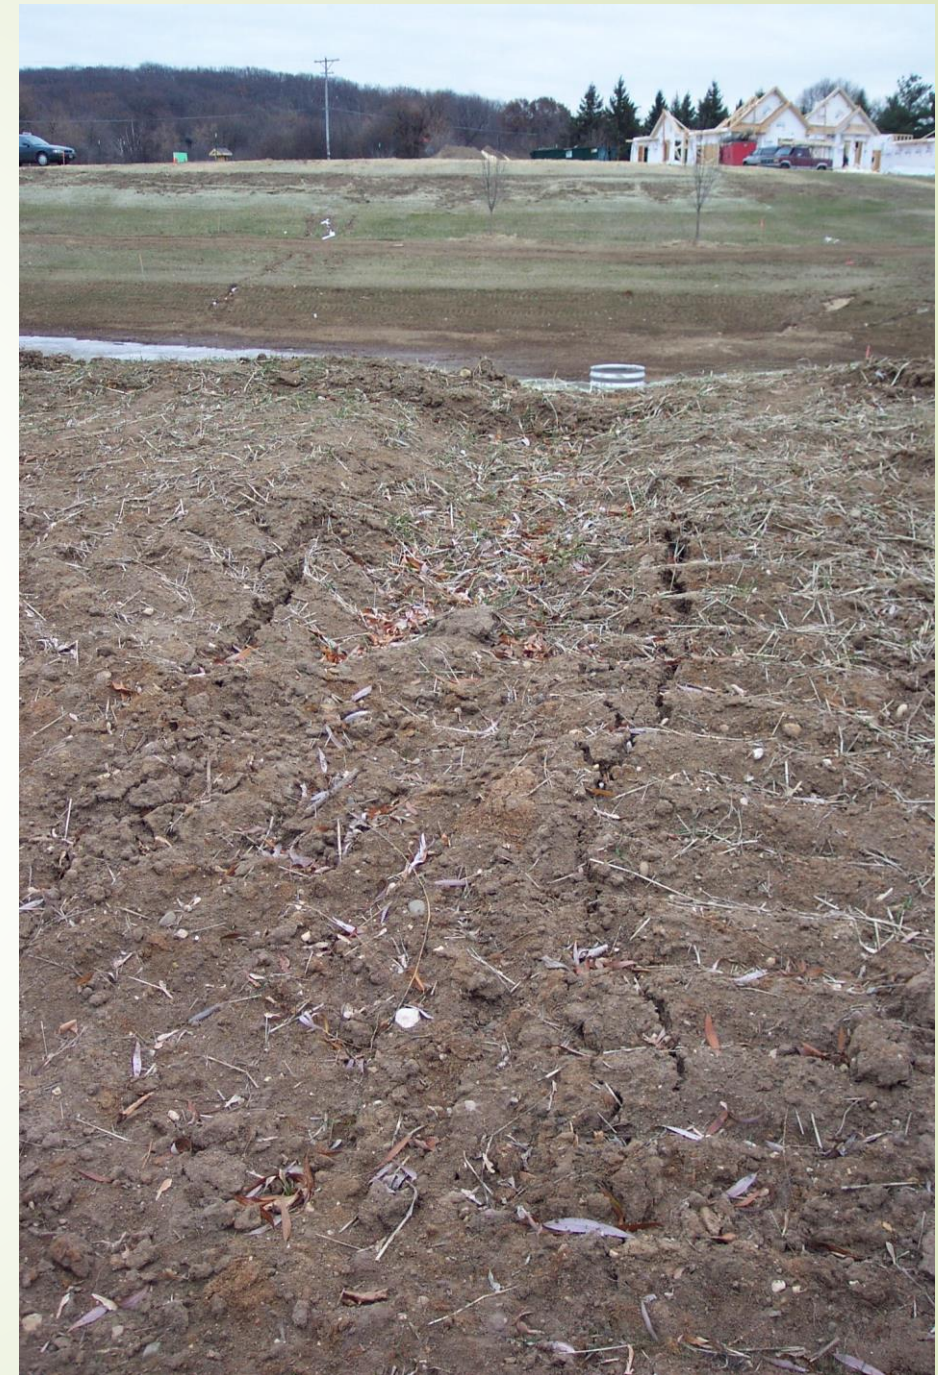
Berm settlement

- Location of spillway
- Are there visibly lower spots on berm? Survey if needed
- Inadequate compaction? Did not allow for settlement?

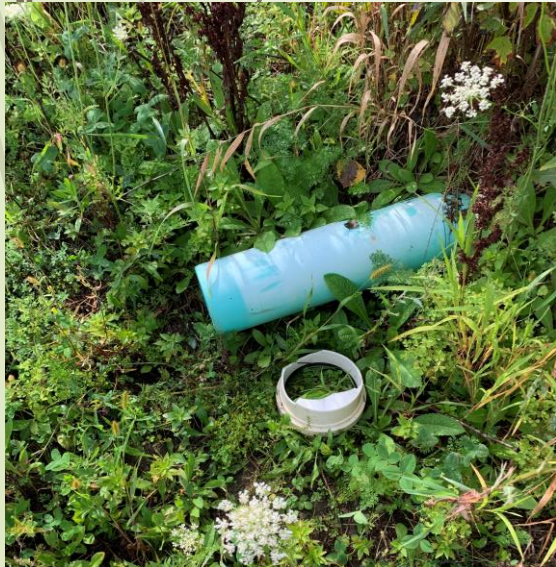
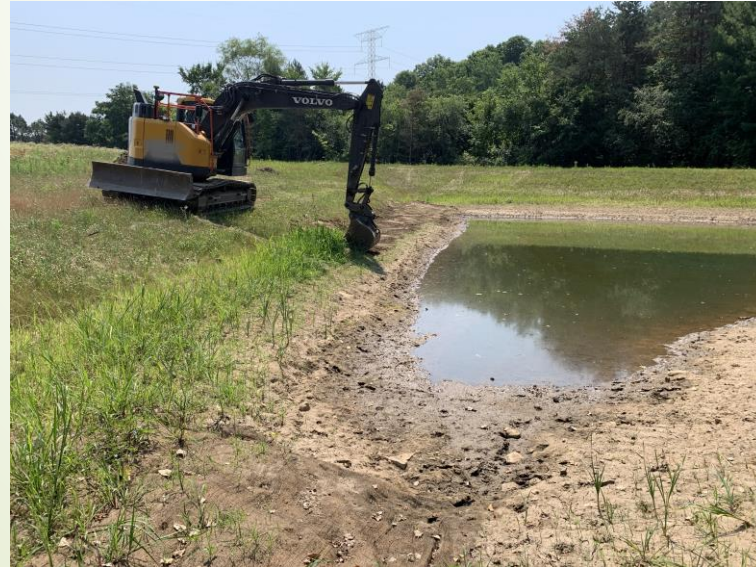
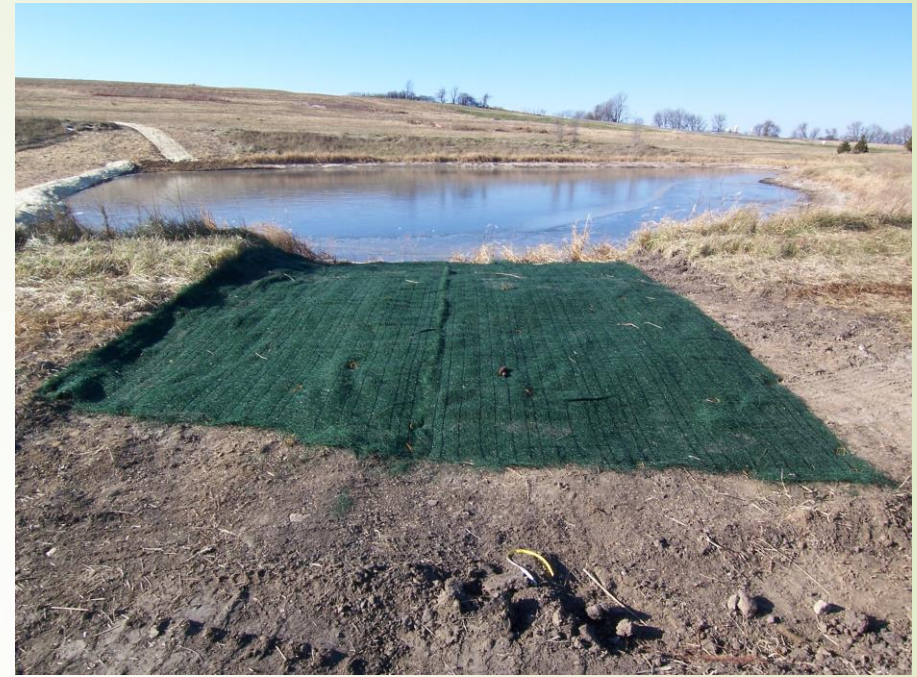
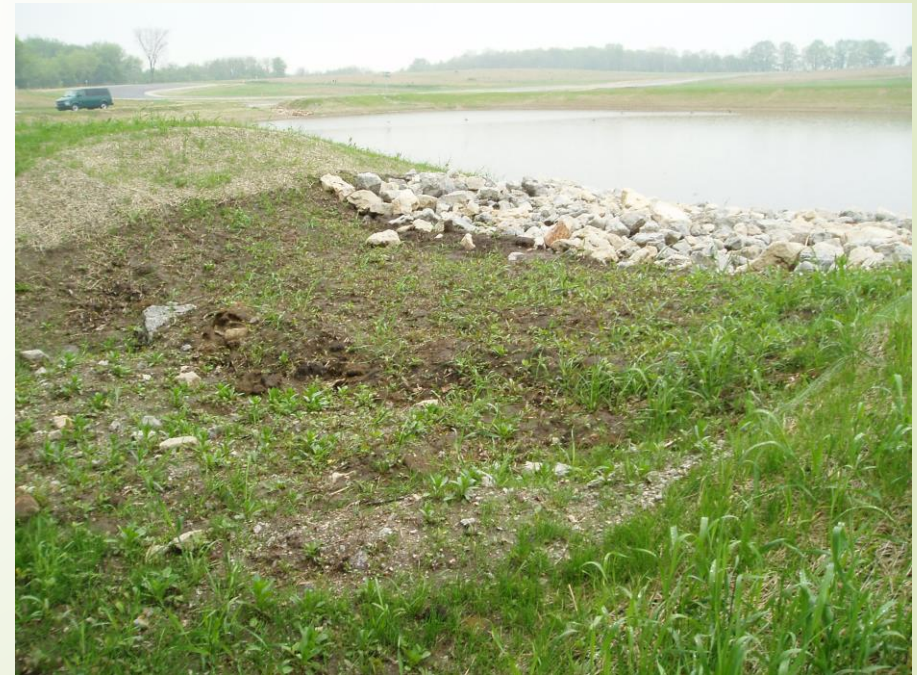
Construction: Missing components / materials

- Safety shelf
- Plug for dewatering outlet
- Riprap / TRM
- Liner
- Low flow orifice protection

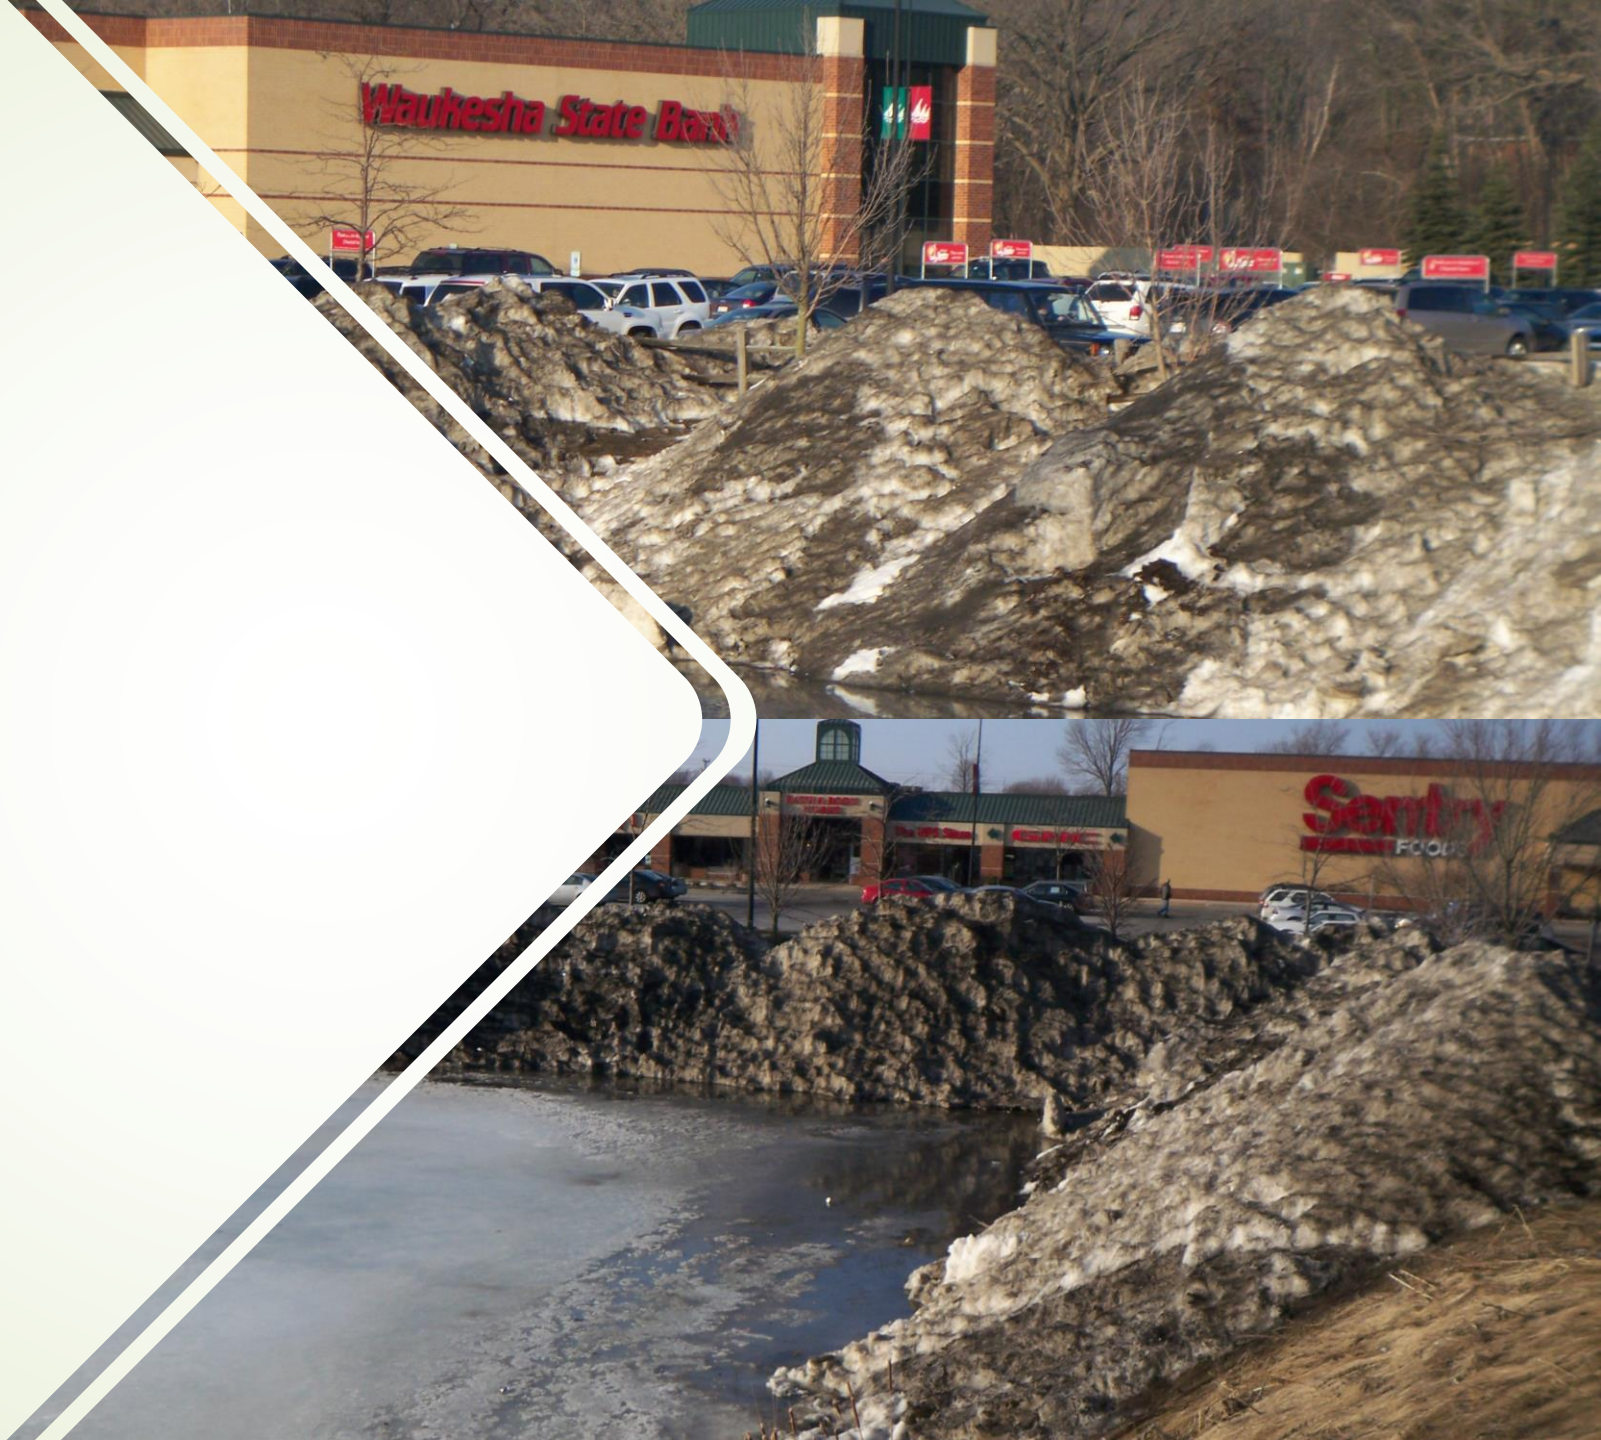
Snow storage

- ▶ Undesirable due to chlorides, vegetation damage, excessive sediment accumulation
- ▶ Look on edges close to parking, large paved areas
- ▶ Signs of
 - ▶ vegetation stress
 - ▶ Sediment piles
 - ▶ Scraped sod

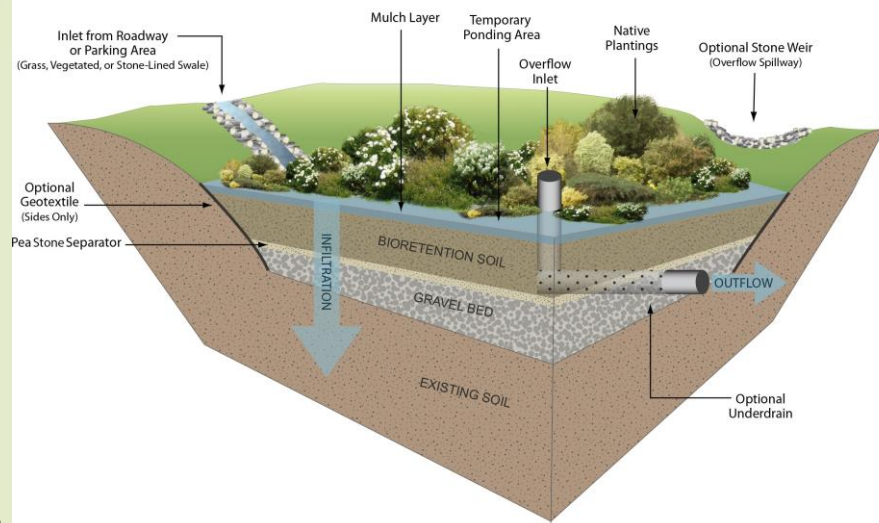
Bioretention Basins

Resources to share- BMP Factsheets
